734333 – Damage on Radiator

Part Number: 734333

For Vehicle: Select VAG Models

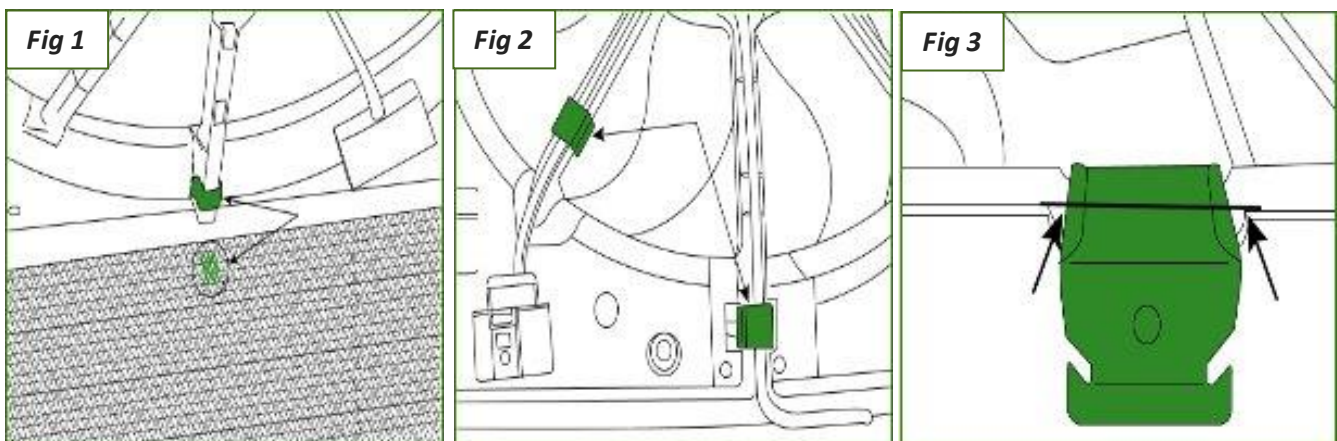
The Valeo Service Technical department have had several claims stating that after fitment of radiator 734333, the vehicle can suffer from coolant loss and/or the coolant level warning light illuminates.

After investigating the issue Valeo technicians have identified that the likely cause is that the radiator has become damaged by a fitting clip on the cooling fan catching the radiator whilst in use.

- 1) Check the cooling system for leaks.
- 2) Remove the cooling fan housing.
- 3) Check the radiator for damage (Fig 1).

- 1) Replace the radiator.
- 2) Check the cooling fan. Check the fan has the correct fitting (Fig 2).
- 3) The clip should sit flush with the bar, so there is no protrusion to catch the radiator (Fig 3).
