## VW Golf - faulty clutch hydraulic pipe

Part Number: 826339

For Vehicle: VW Golf 1.4 10.03-11.08

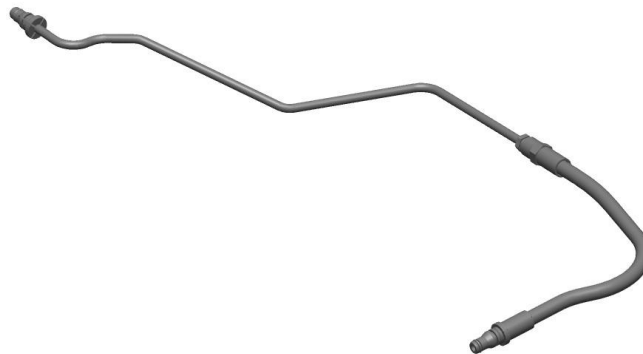
After investigating the issue Valeo technicians have identified that the clutch kit itself is not at fault. The fault is caused by a faulty or worn clutch hydraulic pipe.

Before attempting to replace the clutch kit checks should be made to the pedal box assembly to ensure it is operating correctly. If no fault is found check for correct operation of the master cylinder paying special attention for any leaks that may be present in the hydraulic pipe.

If any leaks are detected replace the hydraulic pipe.
