Water pump replacement and diagnosis

Part Number: Valeo Water pumps

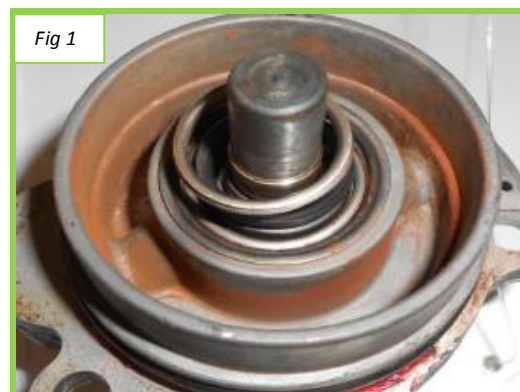
Fig1 - On the areas of the housing in contact with the coolant, there are orange residues showing the pump has been working with a contaminated liquid.

In order to prevent the above it is always recommended during the installation of a Valeo water pump that the vehicle manufacturer's procedures are carried out for fitment, the correct coolant is used and the correct sealant and gaskets are applied.

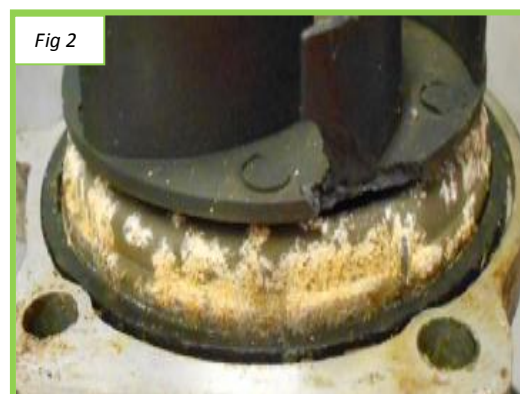
Fig 2 - The areas of the housing in contact with the coolant shows residues of dirt.
