## febi 106547

To fit:  
BMW X5 (E70), X6 (E71)

## Switch for parking brake

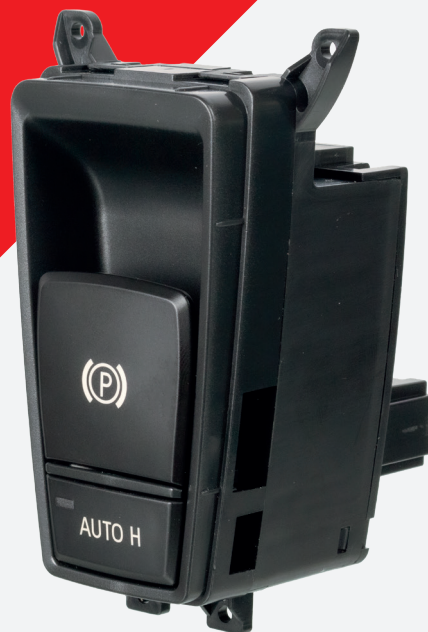
The plastic lever on the parking brake switch fractures when applying the parking brake - making it difficult to engage.

Hot and cold cycles in the interior of the vehicle can cause the plastic to become brittle over time. This can also be influenced by the inconsistent force used by the driver when applying the parking brake.

Open the centre console lid to allow easier access. Using a trim-removal tool, remove the panel with the i-drive dial (if fitted) by carefully releasing the two clips at the back of the moulding. Then, carefully 'free' the other sides and - when released - put to one side (note: the wiring connector may require unplugging).

Unscrew the four T-20 screws from the gear-lever plate which hold the parking brake switch. Next, unplug the wiring connector. Then, remove the connector past the gear-lever (giving you access to the T-10 screws that hold the switch). Unscrew the four T-10 screws and remove the faulty switch.

Fit the new febi switch (106547) and re-fit all previous components and screws in the reverse order of removal. Finally, test the operation of the parking brake and check/reset any fault codes logged in the control unit (using a suitable diagnostic tool).
