Land Rover Freelander TD4, Range Rover TD6

Breather Valve for crankcase, with additional parts

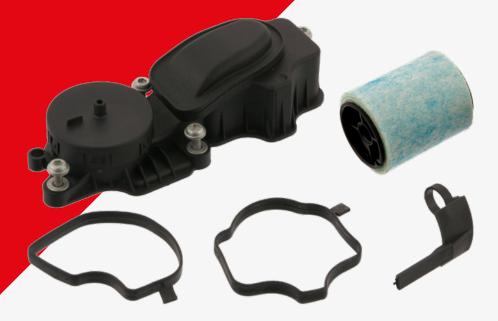
Engine oil leak, usually from the dipstick tube, because the dipstick has been pushed out under pressure.

Other symptoms include lack of engine power; the engine will not increase in speed, black or blue exhaust smoke and excessive oil consumption.

Excessive crankcase pressure caused by a blocked crankcase breather filter, this is located in the depression control valve assembly, which is fitted to the camshaft cover.

Replace the blocked filter and the complete breather valve assembly. Clean any excess oil leaks and test.
