Vauxhall, Opel Corsa C, Combo C, Tigra, Vita

Wiper motor

Windscreen wiper - the wipers are not working.

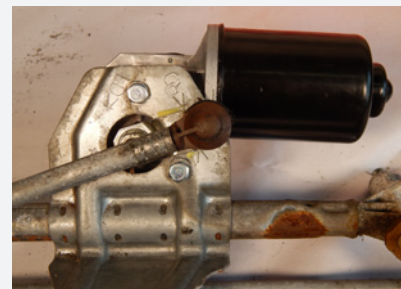
Figure 4

Align the wiper linkage to the splined drive of the motor, making sure it is aligned between the arrows marked LH or RH - depending on vehicle specification - and tighten the new nut supplied. (Fig.4)
