Kubistar - Trapped Starter Motor

Kia Sedona - Easily Accessed Broken Side Door Handle

Fiat Punto - The Driver Should Have Stopped

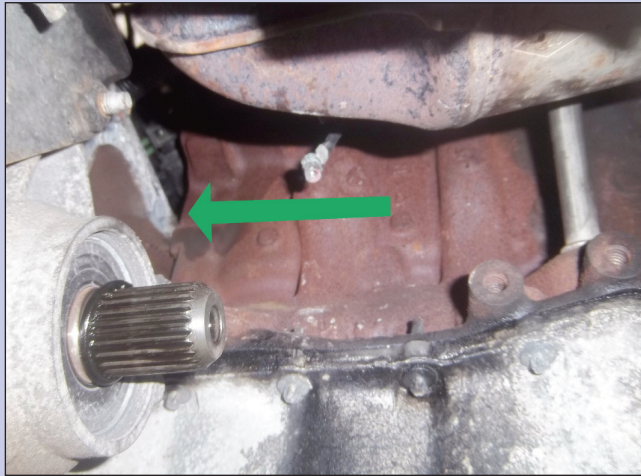
The van was in because the starter motor had failed. Just like the van that bears the Renault badge, the starter motor sits at the back of the engine and will not come out past the driveshaft. The starter itself is quick enough to unbolt, but then the trick is finding a suitable route to remove it from the engine bay.

With the driveshaft out of the way, there was plenty of access to remove and refit the starter motor

The option which I believe to be the easiest, and the one we naturally chose, was to remove the driveshaft. The shaft fits on an external spline from the gearbox, so no oil is lost in the process.

With the shaft removed, there is plenty of room to remove and refit the starter unit. Once the new unit was in place and the drive shaft reinstalled, the Nissan/Renault was ready for the road.

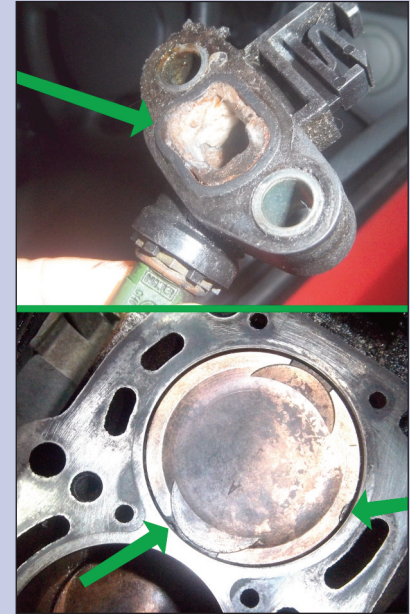
The failed seal on the temperature sender, at top, resulted in damage to the engine block, at bottom.

The source of the problem was a failed seal on the temperature sender outlet, the temperature gauge had begun to rise when the coolant started to escape, it had then gone down when there was insufficient coolant in the system to immerse the sensor.

One of the pistons had picked up on the bore, ruining the cylinder block. A second hand engine was sourced and the owner given a quick lesson on acting upon information from the temperature gauge.

The small leak from the cooling system was easily rectified by replacing the temperature sender unit. The result of the overheating was less easy to remedy. We at first thought that a new head gasket would be required, but once the cylinder head was off we discovered far more damage.
