# febi 32418, 103186

Ford, Mazda and Volvo (various models)

## Control Arm Bush

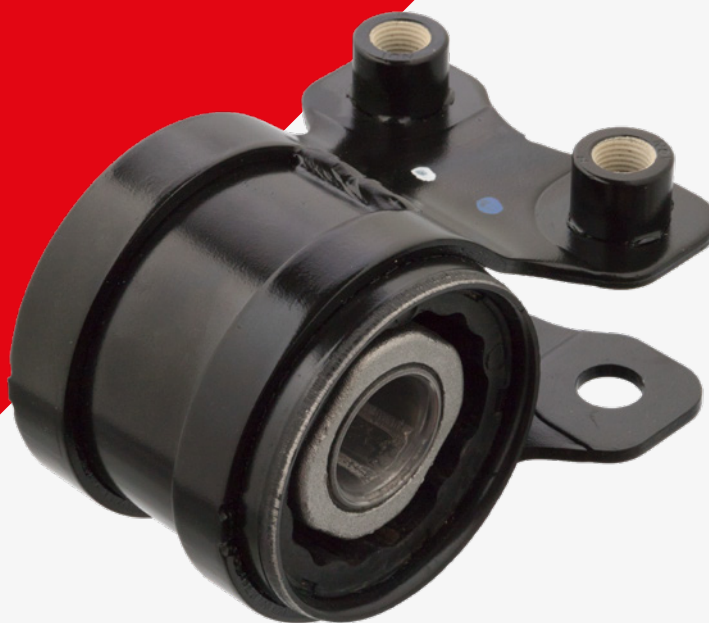
Uneven tyre wear and misalignment of the front suspension.

The lower suspension control arm bush is worn.

febi provides an economical repair solution whereby the control arm bush can be replaced instead of the complete suspension control arm.

When replacing this bush it is important that the alignment of the original control arm bush is followed.

If the bush is not aligned correctly on the shaft of the suspension arm then there is a risk of premature failure and a shortened lifetime of the component.

**Note:** There is a special tool available from the vehicle manufacturer to assist in the replacement of the control arm bush. By using this tool it can be ensured that the installation position and press-fit depth of the bush will be correct.
