# AUTOBIZ

## TECH TIPS

5th Issue  
September 2014

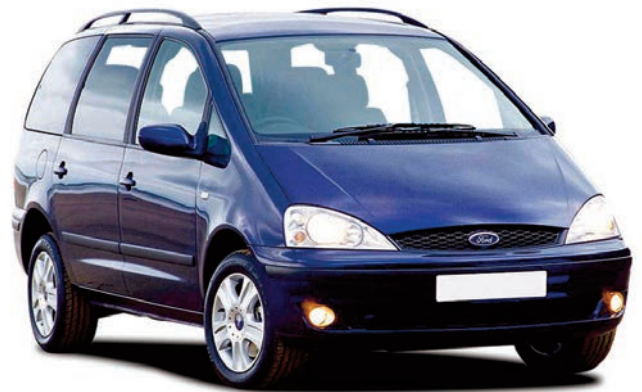
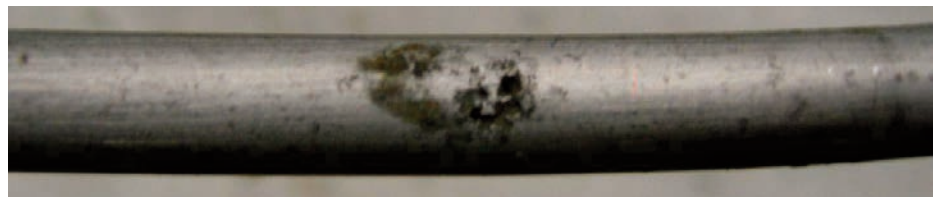
**A pin-hole leak on a fuel line was sucking air into the line, but wasn't leaking diesel yet**

All of the covers on the fuel lines were removed, and the non-return valve was located. There weren't any fuel leaks to be seen, but a small pin-hole was found on the fuel feed line near the tank. While the pin-hole wasn't leaking any fuel (yet) it was allowing small amounts of air to be sucked into the line along with the diesel from the tank, like a straw sucking up air. If the pin-hole had grown larger, it would have started to leak fuel and would have been more noticeable.

A new pipe was fitted, and all of the fault codes and low fuel pressure readings were no longer present. A successful repair of an odd failure.

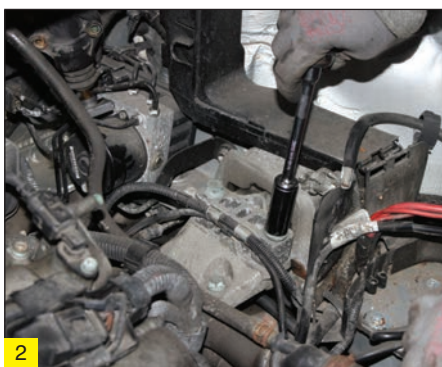
near to the gearbox mounting, and stow it to one side. Support the engine and gearbox with the support cradle and remove the complete gearbox mounting assembly (fig-2). Remove the

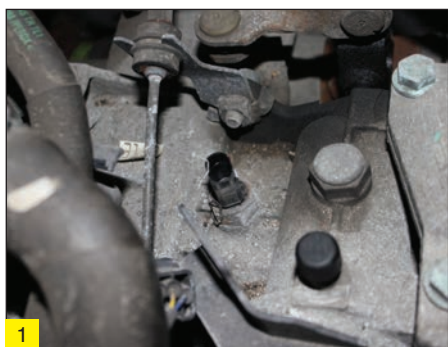
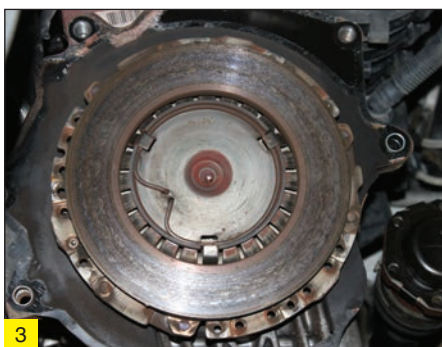
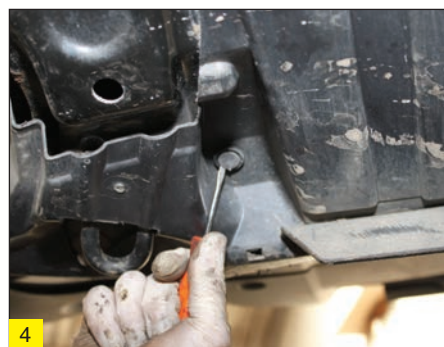
Using a flywheel locking tool, undo the clutch cover retaining bolts and remove the cover. Release the locking ring (fig-3) and remove the release plate from the clutch assembly. Undo the large bolts securing the pressure plate and remove the plate. To replace the release bearing, tilt the gearbox slightly (to

prevent fluid loss) and remove the gearbox end cap. Remove the old bearing from the housing using a large magnet (fig-4) and install the new bearing, ensuring that the end cap is replaced and not reused.

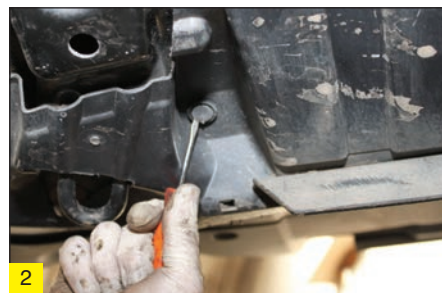
vehicle. Remove the push-in retainer clips that are holding the under shield flaps inside the wheel arch, there are two clips on each side. Remove all retaining push-in clips holding the under shield in place. There are quite a few, and you will find two that are hidden, one on each side towards the front that also need to be removed (fig-2). Pull away the complete under shield, taking extra care of the flaps from inside the wheel arch, as it is all one piece. Support the engine and gearbox with transmission

Remove two nuts and one bolt on each side so that secures the lower suspension arm to the ball joint and unlink. Remove the rubber bracket from the exhaust closest to the catalytic converter. Unlink the front end prop shaft by slackening the four double hex bolts. Remove the bolt that secures the power steering pipe bracket to the subframe (fig-3) and unclip the pipe from the two clips holding it in place.

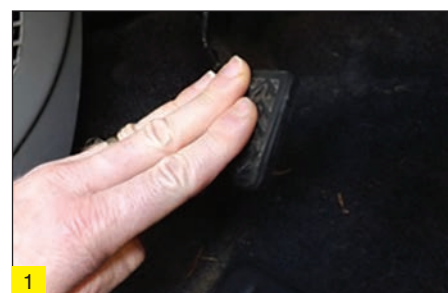
1. Push the clutch pedal down by hand (Fig. 1) checking for smoothness of operation. Stiffness or roughness in operation will require further investigation to determine the root cause.
2. Measuring the free play in the pedal can be done quickly and easily, by applying

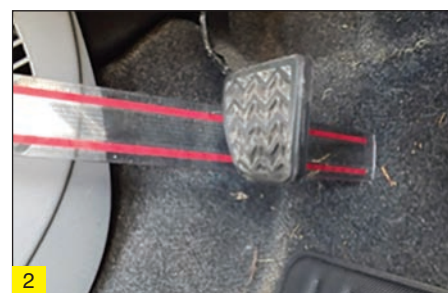
(approx 15-20Nm) until you feel the amount of pressure required increase. Measure the distance travelled by the pedal with a ruler. The amount of free play in the clutch pedal should be 23mm, +/- 5mm (Fig. 2).

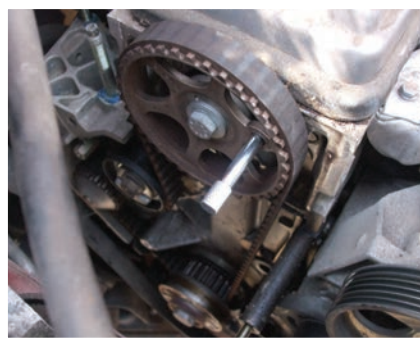
Special tools are sometimes crucial and will save you time and trouble

VMs will develop an accurate timing process and tools that produce repeatable and reliable engine or fuel pump timing, in a production environment to give maximum performance and minimum emissions every single time. If that involves some expensive special tools, then that is what is required and a bottle of Tipp-Ex just won't give the same results!

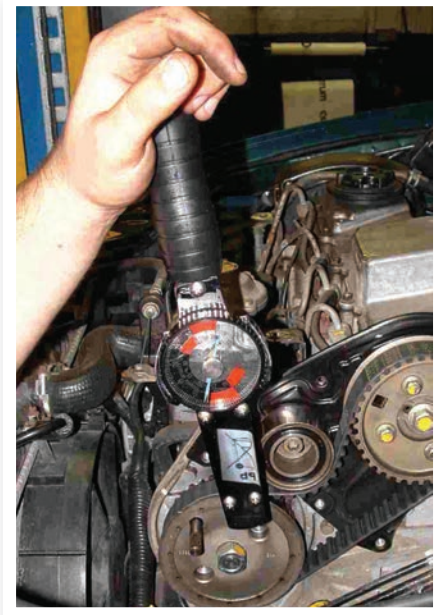
Torque wrenches and values are vital
