LuK Clutch Academy

2014 Hyundai i30

REXPERT Alistair Mason is investigating a clutch fault on a 2014 Hyundai i30, which has covered more than 162,000 miles. The customer had reported that it was difficult to get the vehicle into gear. With full workshop instructions available on Schaeffler's REXPERT online information system, and little investment in workshop tooling required, this makes a great repair for any independent workshop. Scheduled time for this clutch replacement is 3.4 hours.

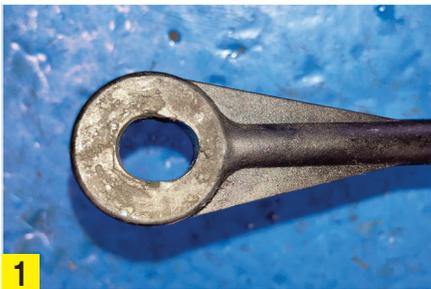
On initial diagnosis, it was noticed that there seemed to be restricted clutch pedal travel and a lot of free play in the pedal, due to excess wear at the clutch master cylinder to pedal connection (Fig 1).

The clutch master cylinder was replaced, the clutch bled and full clutch pedal travel restored, but gear selection with the engine running was still difficult. However, with the engine switched off, the gears could be selected easily, which indicated that the clutch was not fully disengaging. Authorisation was given to remove the gearbox for further investigation.

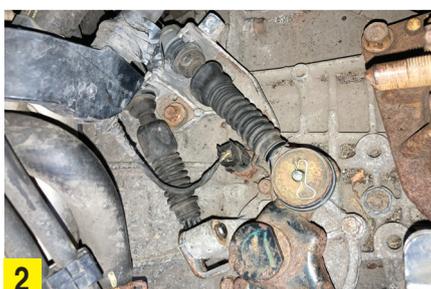
battery tray, and then the engine ECU. This gives good access to the top of the gearbox (Fig 2). Remove the engine speed sensor from the back of the bellhousing, disconnect the reverse light switch, gearbox earth strap, then disconnect both gear change cables and cable bracket, and stow them out of the way. Remove the upper bellhousing and starter motor bolts, then fit the engine support, if a bridge system is being used.

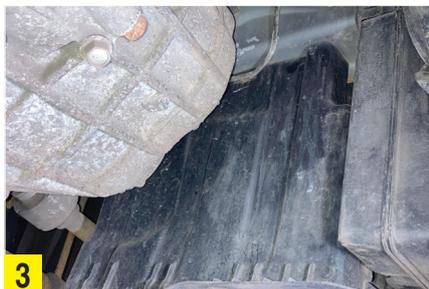
Before raising the vehicle from the ground, slacken both front hub nuts (note – on reinstallation, new hub nuts may be required if the locking tabs break), then raise the vehicle lift to waist height and remove both front wheels. Raise the lift to gain access to the underside, remove the engine undertray and the N/S splash guard (Fig 3) and drain the gearbox oil. While the oil is draining, disconnect both front bottom ball joints, ease the outer CV joints out of the hub assemblies and remove the driveshafts from the gearbox. The driveshafts may need to be levered out.

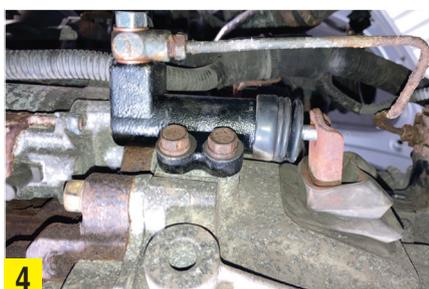
Remove the two hydraulic clutch slave cylinder retaining bolts (Fig 4) and the flex

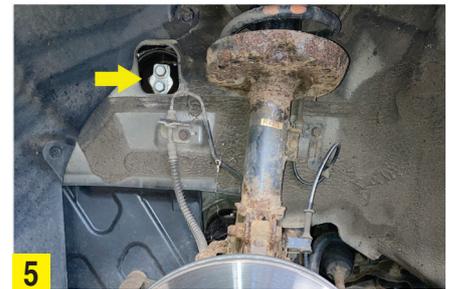
remove the two gearbox mounting bolts that are accessed through the inner wing (Fig 5), then lower the lift and remove the mounting from the gearbox. Raise the lift to gain access to the underside, support the gearbox with a transmission jack and remove the final bellhousing bolts. Ease the gearbox away from the engine. When the gearbox input shaft is clear of the clutch, lower the gearbox, remove the gearbox from the vehicle and place it somewhere safe.

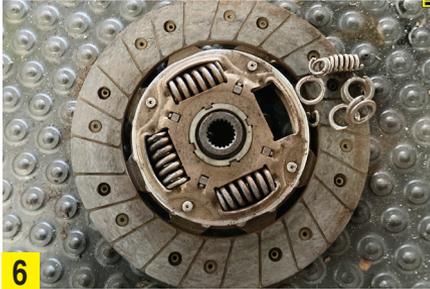
Remove the clutch assembly from the flywheel by unscrewing the nine clutch retaining bolts, and ease the clutch off of the flywheel. At this point, the fault in this repair was identified (Fig 6): One of the clutch plate torsion damper springs had broken, come out of its retainer and was affecting clutch operation and clearance.

This spring can break from excess load/hard driving or vibration, from an engine misfire for example, being transmitted through the clutch, causing the springs to fully compress and then break.

With the clutch removed, clean the back of the engine and flywheel with clutch and brake dust cleaner, inspect for any leaks, and rectify if required. Also, remove the glaze from the flywheel clutch plate surface using an Emory cloth.

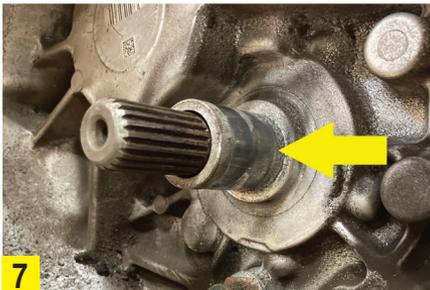
Remove the release bearing from the gearbox and clean the bellhousing area with clutch and brake dust cleaner, and check the bearing guide tube for wear (Fig 7) as it is known for both Hyundai and Kia engines to wear in this area and cause release problems.

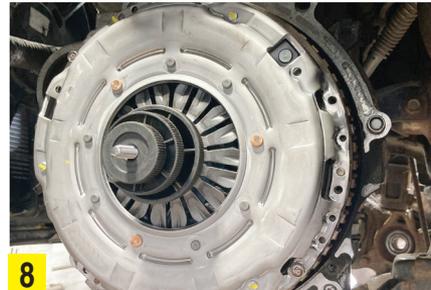
Clean the new clutch pressure plate with clutch and brake dust cleaner, to ensure the face is degreased and, using a clutch alignment tool, mount the new clutch (Fig 8). Tighten the bolts in an even and sequential manner and then torque to the

manufacturer's specification, before removing the clutch alignment tool.
