Discovery ABS Sensor Problem

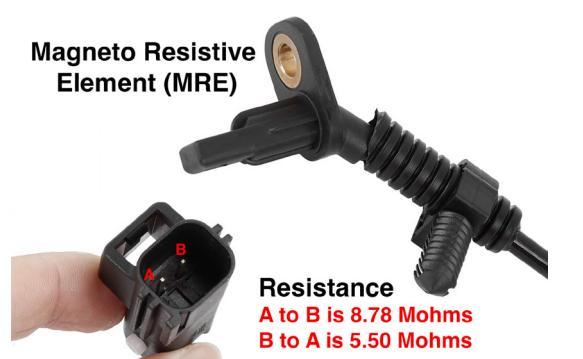
This first step is to compare the voltage levels from the bad side loom to the opposite side connector that has not displayed a fault. Typically, the voltage recorded between the 2 connector pins will be 12.0 volts. In this case the voltages were the same, 12.0 volts,

indicating there were no loom or ABS/ESP module issues.
