Parasitic drain evolves **into a non-start**

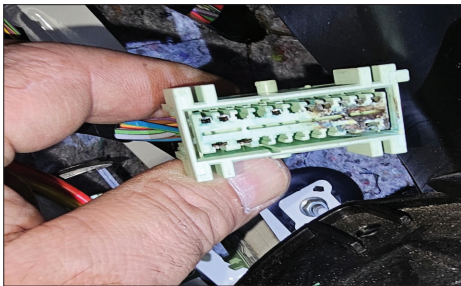
This is a very common call to the Autobiz Technical Helpline, and we sent the known solution to the technician to check a few things. It is a common occurrence on this model that the windscreen washer pump leaks, and the windscreen wash wicks up the loom, making it's way into the body control module. Once at the control module, corrosion begins to foul the pins and wiring. Then the corrosion continues into the control module, causing even more widespread damage.

Significant corrosion on this body control module connection plug, and severe damage the body module pins was quickly spotted. The extent of the damage meant that a new body module needed to be installed, and the connection plug was re-pinned. And a new washer pump was fitted.
