## 3 System failures from 1 Actual fault

## Case Study - Peugeot 207 1.4 2008 KFU

## Range Rover/Jaguar MAF issues

## Case Study - 2009 Discovery 4 3.0 TDV6

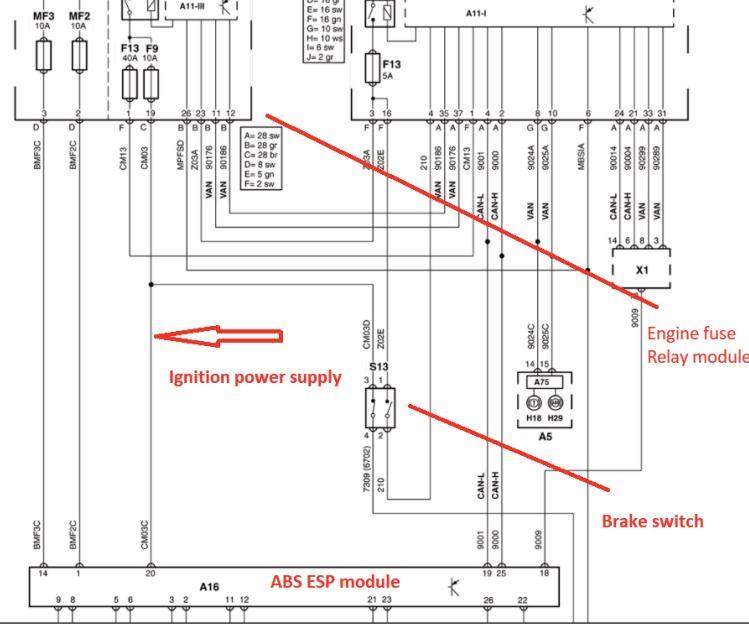
Corrosion in the relay connector caused a short circuit and faults

On checking the circuit diagram for the brake light switch, a link was noticed to the ABS ignition power supply. A quick load test at the ABS module revealed a volt drop on that circuit.

Further investigation revealed the root cause of all the issues: Water damage to the switching protection unit. A replacement

switching unit was fitted and the multiplug was repaired. No further issues reported and all faults were cleared.
