## Intermittent Faults

### Case Study: 2008 Hyundai Santa Fe 2.2 CRDi

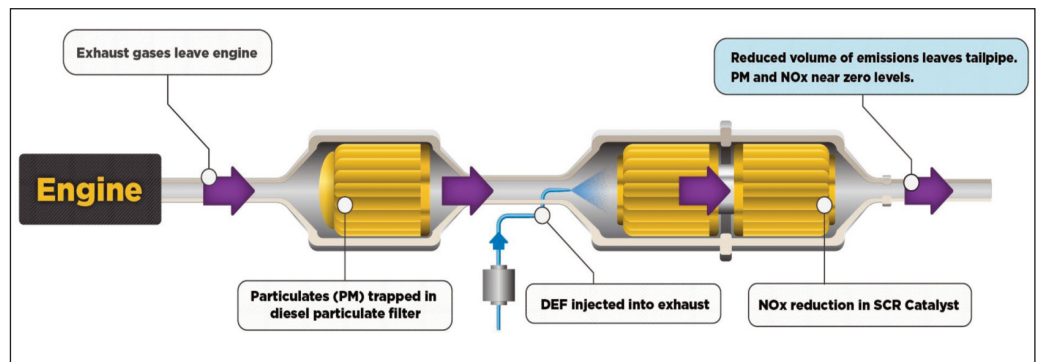
The dosing unit can suffer from a buildup

of solids such as Ammonium Nitrates and Sulphates that can block the flow of the fluid, and in some cases, it can hold the dosing injector open. This can result in very heavy consumption of fluid. The NOX sensor, located after the SCR Catalyst, can suffer from excessive flow of fluid, not to mention a failure of the SCR Catalyst as well.
