Spin Doctors

Written by Charles Figgins - Blue Print Technical Consultant

The Mitsubishi L200 pick-up is well known for its ruggedness and load lugging capabilities. The example in question is a 2003 model, which is regularly put to work pulling a mini digger in addition to other ground work duties. The vehicle has covered over 140,000 miles and was still going strong; until a few months back.

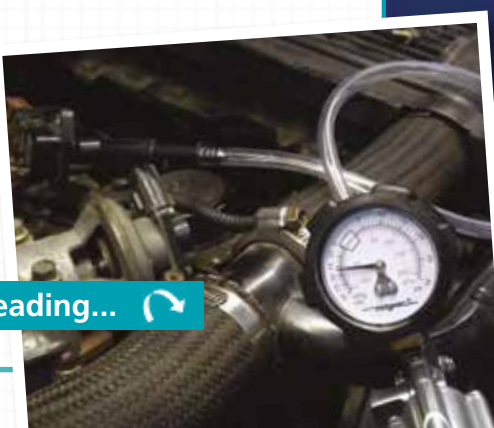
I then turned my attention to the control solenoid which is found under the intercooler pipe. Once it was removed, I checked its resistance across the two terminals using the multi meter function on G-Scan 2.

The reading was 32 Ohms; this was within the tolerance of (29-35 Ohms at 20C) (Figure 7).
