# Sensing a commercial issue...

Written by Jim Gilmour - Blue Print Technical Consultant

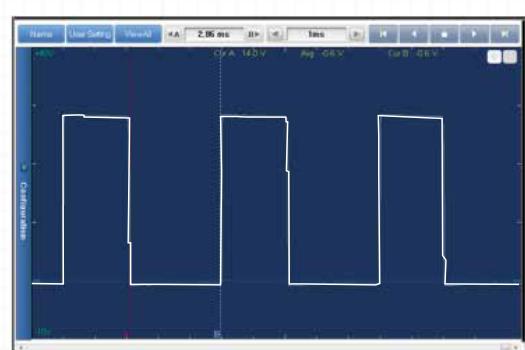
Figure 5

Based on the information I had, I concluded that the SCV was sticking, which caused the erratic fuel pressures recorded by the G-Scan 2.
