Technical Bulletin

Ignition Coil ADC41473

Date Issued: 01/06/2005

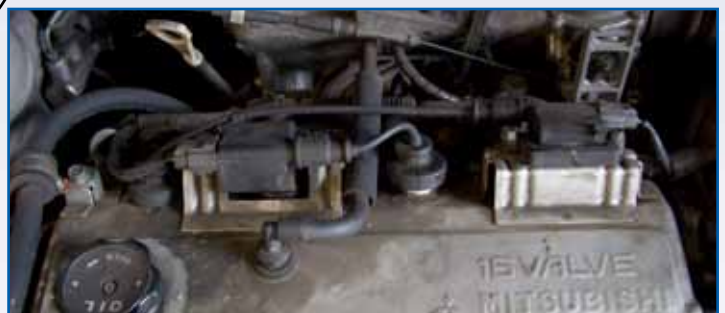
Progressive insulation failure of the coil or spark plug tube is most often experienced where a misfire is detected during cold/damp conditions (e.g. from cold starts) or during high engine loads. This can be exacerbated by dirt contamination or high resistances in the spark plug or HT leads. Tracking can sometimes be visible or audible during operation, and may leave carbon traces where regular tracking to earth is occurring.

Example B shows where the spark has tracked along the spark plug ceramic (see burn marks).

Blue Print strongly recommend that the spark plugs and HT leads are replaced in addition to the coil assembly, or that they are carefully checked. We also recommend that a logical diagnosis procedure is followed (prior to replacing the ignition coil) to prevent it being replaced unnecessarily.
