Technical Bulletin

ADZ91107 and ADZ91113 Alternators

Date Issued: 01/11/01

We are aware of common vehicle faults associated with the charging system on Vauxhall applications using the Isuzu 1.5 and 1.7 diesel engines. The aim of this bulletin is to allow the correct diagnosis prior to replacing the alternator, and to assist in the prevention of further problems.

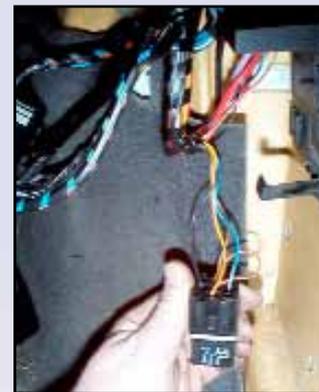
fig 5. - Relay removed

It is our experience that the Charging Lamp Relay is prone to failure. The relay controls the dashboard charging light operation and alternator excitation. It also gives a signal to the diesel system self-diagnostics and glow plug control unit for post-glow operation.

- **We strongly recommend that the relay is changed as a matter of course when replacing the alternator, as it is possible for an internal alternator fault to damage the relay whilst in operation.**
