# CITROËN / PEUGEOT REAR BRAKE DISC INSTALLATION

Issue Date: 03/2019 Issue Number: BRTB0004B

**APPLICATION:** Citroën C4, C4 Grand Picasso, DS4, DS5, Peugeot 308, 3008, Berlingo, Partner

**APPLICABLE REFERENCES:** BBD5841S, BBD5842S

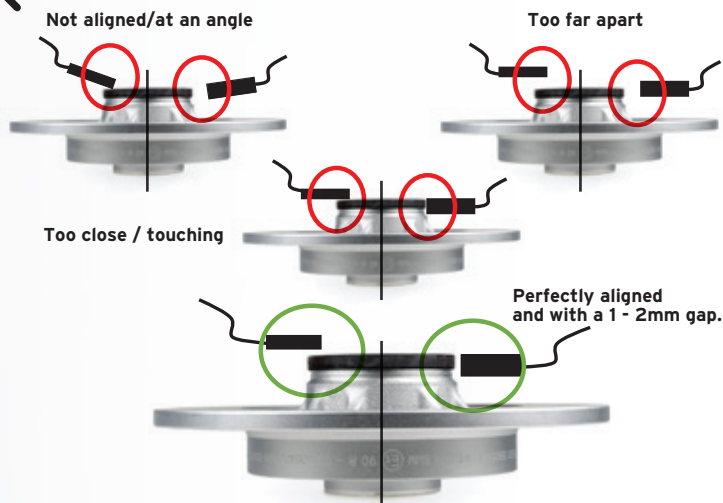
If once a new disc has been installed you can see that the ABS Sensor is contacting the magnetic reader, or the gap is not aligned correctly, then the disc and ABS Sensor should be removed, taking care not to damage the ABS Sensor. Once removed, clean the rust and corrosion from the ABS Sensor seating location. When sufficiently cleaned and correctly seated, with the disc re-installed, you will be able to see a clear 1-2mm gap.

Below you can see two examples of ABS Sensors located in different positions, however the principle remains the same.

To avoid damage to the magnetic encoder, keep it away from magnetic fields. The plastic cap protecting the seal should only be removed just before fitment.
