Eure!Car Tech Blog highlights

Peugeot 206 and 206+

Instrument panel faults

Peugeot 107, Citroën C1 and Toyota Aygo Power steering problem

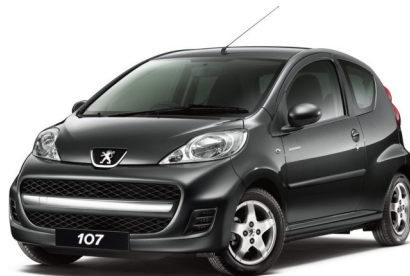
This post discusses a peculiar failure in the power steering system of the Peugeot 107, Citroën C1 and Toyota Aygo models. All engines are included in this fault.

The main symptom is a failure of the power steering that may occur frequently or sporadically. If the errors are read, the possible codes that can

- C1552 - Power supply malfunction PIG - Internal circuit of power steering unit
- C1554 - Power steering failure - Power relay failure

Replace the two relays of the power steering unit named above.
