Eure!Car Tech Blog highlights

Combo/Corsa 1.3 CDTi with Z13DT Engine Chronic DPF Regeneration Failure

Astra H 1.9 CDTi with Z19DTH Engine Difficulty shifting, stalling

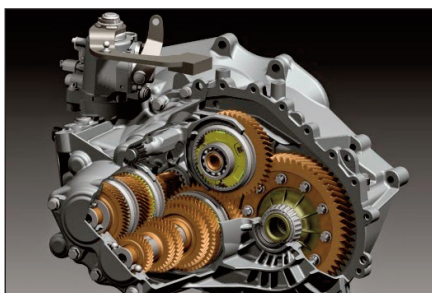
Some Opel Astra H 1.9 CDTi cars with Z19DTH engines experience difficulty in engaging first gear, do not move forward after engaging third gear and the engine stalls on releasing the clutch pedal in 1st gear.

The first thing that must be ruled out as a cause of this problem is a defect in the selection mechanism, between 1st and 3rd gear, as these can engage simultaneously and generate the described symptoms. It is likely that the fault is caused by an internal problem inside the gearbox.

It is likely that the gear selector fork between 3rd and 4th gear is bent. In our experience, the most common cause of this incident, is a defect in the 3rd to 4th gear selector fork. The fork can deform and cause this fault. The solution involves replacing the defective fork

The replacement procedure involves removing the gearbox and then the housing cover, by unscrewing the 16 bolts that secure it to the gearbox. The joint area must be cleaned with a gasket remover liquid or spray.

Disassemble the reversing light switch and remove the gearbox in order to be able to work comfortably. Engage neutral, remove the selector lever and extract the input shaft. At this point, remove the 3rd to 4th gear selector fork. Best practice before the replacement of the fork requires cleaning the thread burrs of the 16 holes in the gearbox housing and cleaning the swarf that remains. This ensures there is no foreign material inside the gearbox that could cause future damage. It is recommended to clean the housing magnet.

Replace the fork with the correct modification and follow the assembly process for the input shaft, not allowing it to twist and preventing the forks from resting on the linking sleeve. Fit the reversing light switch, tightening it to 20 Nm.
