Timing belt/kit installation on GM (Isuzu) 1.7D engines

GATES REFERENCE:5563XS/K015563XS/K025563XS/K035563XSMAKE:CHEVROLET, OPEL, VAUXHALLMODEL:Astra, Combo, Corsa, Meriva, Tour, ZafiraENGINE:Isuzu 1.7 DTIENGINE CODE:A17DT, A17DTR, Y17DT, Y17DTH,
Y17DTL, Z17DTH, Z17DTH, Z17DTR

Questions and returns out of the field teach us there are still a lot of doubts on the contents/installation of this belt/kit, so we believe it is useful to launch a new bulletin on this engine. This replaces Technical Bulletin N° 009.

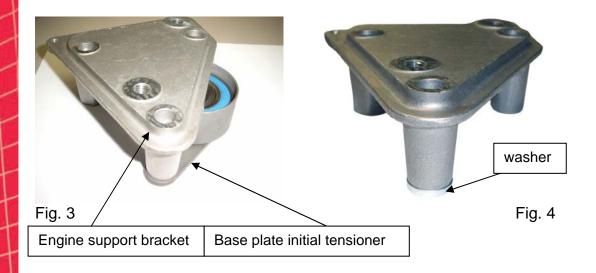
As the initial tensioner base plate was sitting under one of the legs of the engine support bracket (Fig. 3), K015563XS can only be used from engine nr 328704 on.
