035

Technical Bulletin

Timing belt/kit installation on VAG 1.4/1.6 16V

GATES REFERENCE :	5565XS/K015565XS/K025565XS/KP15565XS/ KP25565XS-1/KP25565XS-2/T43149	
MAKE :	AUDI, SEAT, SKODA, VOLKSWAGEN	
MODEL :	Various	
ENGINE :	1.4 16V, 1.6 16V	
ENGINE CODE :	Various

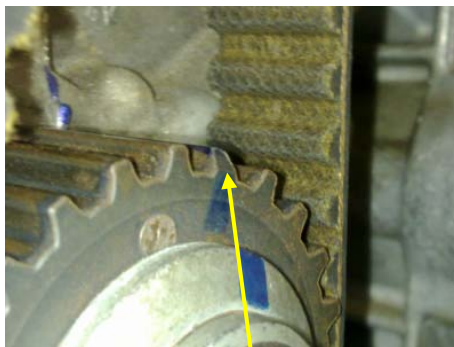
Fig. 12

Slanted tooth of the crankshaft pulley (Fig. 12) has to be in line with right hand positioning rib (Fig. 13).

Slanted tooth

Put engine at Top Dead Centre (TDC).

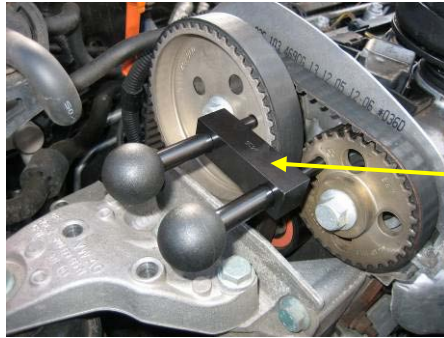
Fig. 14

GAT4635

Block the camshaft pulleys (Fig.14); use Gates tool GAT4635 (VAG tool ref. 10016).

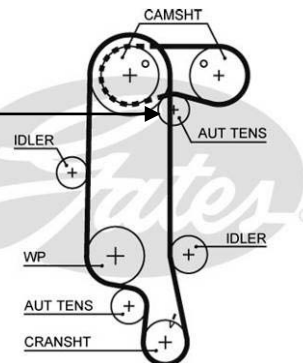
It is clear an incorrect position of the locating lug will lead to problems like tensioner misalignment with drive failure as a result.
