## **Audi / Seat / VW**

### **With air-conditioning system and compressor without magnetic clutch**

#### **Compressor does not work**

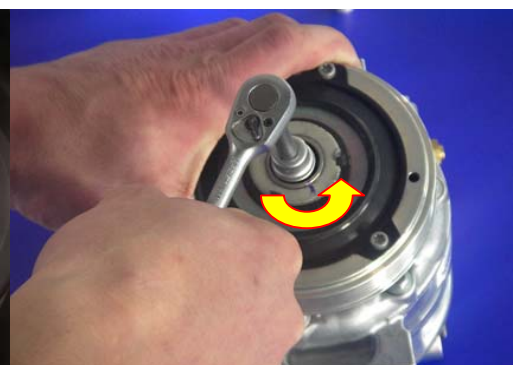
Fig. 5

2. The overload protection has interrupted the frictional connection to the drive plate (Fig. 4). The drive plate and the rubber element can be replaced individually. Prerequisite: The compressor can be turned easily.
3. A triggered torque limiter cannot necessarily be detected visually. In order to check if the limiter has triggered, the compressor shaft must be held still using a suitable tool (Fig. 5), and the pulley simultaneously turned to the left. If the pulley can be turned to the left, the limiter has triggered, and the compressor must be replaced. In the case of the compressor types Sanden PXE 13 and PXE 16, replacement of the torque limiter is not possible.
