BULLETIN

Peugeot 307 HDI Engine code: 9HZ (DV6TED4) Model year: 2004 - 2005

Poor acceleration performance
Noise in the vicinity of the splash wall
Engine control lamp lights up sporadically
Fault code: P0100, P3008

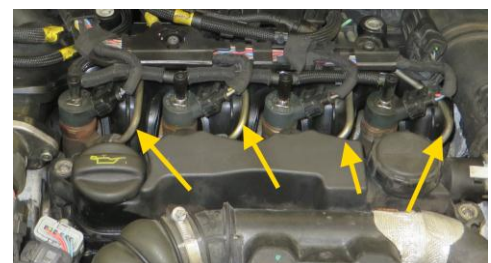
The intake manifold consists of two plastic housing halves bonded together. A leaky bonded joint (A) causes air to escape as boost pressure increases, while also making a distinctive noise. Depending on the size of the leak, the following fault entries may occur in the engine control unit.

If a leak is detected, the intake manifold must be completely replaced. It cannot be repaired. Replacing the intake manifold requires removing the high-pressure fuel lines for the injection valves (injectors).

In order to avoid leaks later, carefully remove and re-install the lines.

Carry out an extensive test drive!
