LuK Clutch Academy

Citroen C5 2.0 HDi (RHZ)

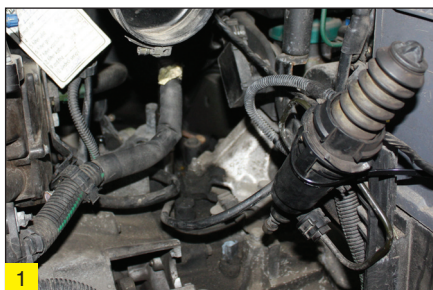
Remove the pipes from the intercooler to the turbo, and their securing brackets attached to the gearbox. Remove the gearbox inspection plate (fig2) and the three bolts for the gear linkage support bracket, then disconnect the brackets securing the air conditioning hoses (fig3) and stow clear to one side. Carefully pull the O/S drive shaft out of the gearbox, undo the N/S drive shaft bearing support and pull the drive shaft out of the gearbox.

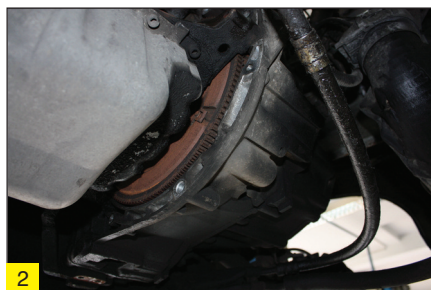
than 15-30mm of free rotational movement between the primary and secondary masses. Any movement greater than this, or if there is no movement at all, then it is recommended that the DMF should be replaced. On this occasion, the radial tolerance was within specifications but the axial tolerance, which is allowed 1.6mm, was outside its limit as we reached 2.1mm so the DMF was replaced.

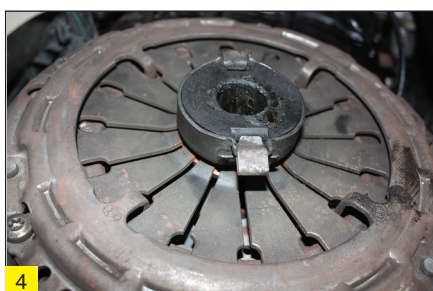
Refitting the gearbox is the reverse of removal, however the new release bearing will have to be attached to the new release fork (fig5). Do not locate the bearing back into the cover. With the gearbox back in place, the release bearing can then be snapped into the cover with the aid of an appropriate lever through the clutch cylinder aperture (fig6). You will hear a nice healthy 'click' as the bearing locates into the clutch cover. To ensure the bearing is connected fully, carefully operate the fork with the lever in the other direction to operate the clutch. As there is no gearbox level plug the gearbox is topped back up through the reverse plunger aperture with 1.8 litres of vehicle manufacturers specified transmission oil.
