# Intake manifold/electric drive module

Possible fault cause and replacement

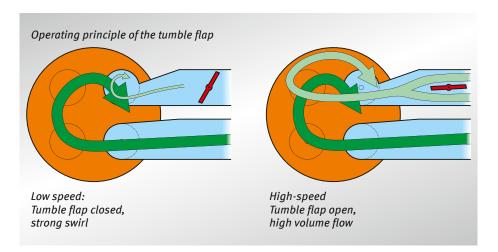
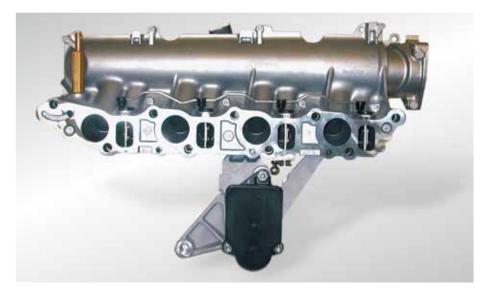
Intake manifold 7.00373.12.0 with drive module 7.00521.14.0

The true fault cause are often worn out, tight tumble flaps in the intake manifold. The drive module can no longer move the tight tumble flaps and indicates an error.

The position of the tumble flaps in the intake manifold itself is not acquired. This can only be performed indirectly through the angle position of the drive module. For this reason malfunctions at the tumble flaps or at the lever the arrangement are sometimes attributed to the drive module.

For this reason when exchanging the intake manifold, also the electric drive module must be replaced by a new one. The "old" drive module can no longer be used.

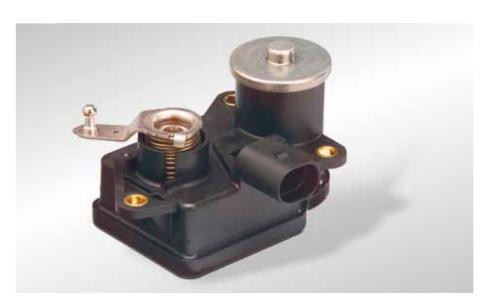
Electric drive module EAM-i

An integrated angle sensor acquires the actual position. In case a deviation with respect to the setpoint position is detected, this is then indicated as an error to the engine controller.

The cause for these malfunctions are often stiff or sticking tumble flaps.
