Chain tensioner

fits
BMW E87 116i with
N45 115 PS / 85 KW engines

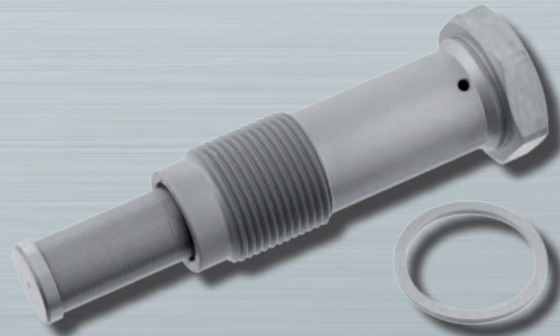
**1****OLD**

The original version (repl. No 11 31 1 439 851) of the chain tensioner has a larger hole above the thread (see Fig. 1). The car manufacturer fitted this version of the chain tensioner in the vehicles referred to above. The result is that the chain can jump under unfavourable loads. In the worst case, valves and pistons come into contact with each other - resulting in engine damage. This version has been replaced by the car manufacturer and is no longer in use.

SWAG recommends using only current chain tensioner SWAG 20 92 1275 (repl. no. 11 31 7 567 680). This chain tensioner has a small hole below the head (see Fig. 2). Consequently, these ensure perfect guidance of the chain under all conditions and prevent jumping.
