Wheel bearing kit including wheel bearing and axle nut

fits Audi A2, Seat Cordoba, Seat Ibiza IV, Škoda Fabia, VW Polo, VW Fox

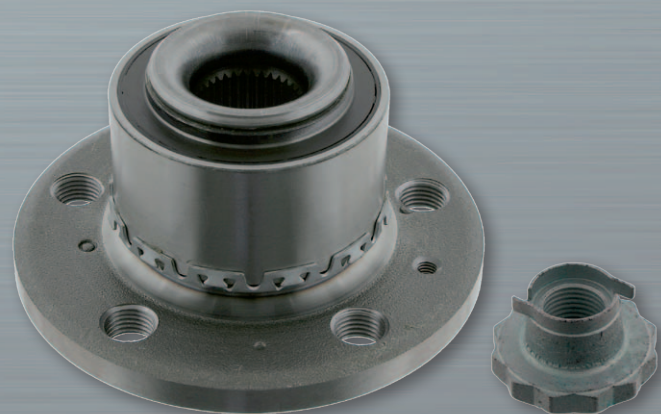
The wheel bearing makes a lot of noise when driving.

Water is getting into the wheel bearing due to a damaged sealing washer and rust is forming, see photos (1) and (2). The sealing washer (3) located between the CV joint and the wheel hub is made of plastic and is easily damaged during removal or due to external factors. When the sealing washer is damaged, it no longer makes proper contact. Water can get inside the wheel bearing more easily once the sealing washer is damaged or dirty. The consequences are premature failure of the bearing and a lot of noise.

Using inappropriate tools for fitting may cause premature failure of the wheel bearing and may also cause a fault indication in the ABS system. Please follow the vehicle manufacturer's repair instructions!

Look out for damage to the sealing washer! As a general rule, SWAG recommends replacing the sealing washer when fitting a wheel bearing. Important: The sealing washer comes in two sizes (64 mm and 72 mm). Pay particular attention to the size (in inches) of the wheels!
