Previous Technical Bulletins

CL 045 Fitment of friction plate in kit 826033

Vehicles: Citroen - Berlingo, C3, C5, Dispatch, Relay, Xsara Fiat - Ducato, Scudo

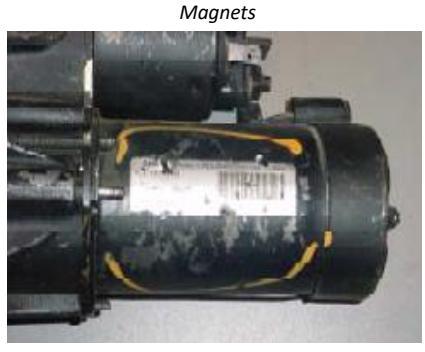
There must not be heavy shocks when mounting a starter or an alternator on the vehicle engine. Description

On permanent magnet starters (ex: D6RA), heavy shocks on the starter's body (fall, hammer shocks, ...) can generate the detachment of the magnets and sporadic breakdowns of the starter.

If the starter defect is due to heavy shocks during the mounting process, the warranty will be refused by Valeo. The main technologies concerned by this problem are permanent magnet starters (ex: D6RA) and internal ventilation alternators (A11VI, A13VI,...)
