# febi Highlight

## Ball Joint ProKit

febi no. 28355/38490

Fits: Citroën C5, C6 /  
Peugeot 407, 508

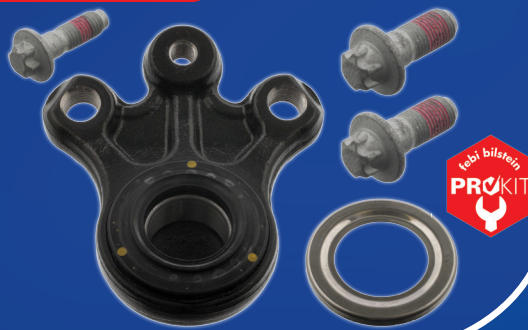
The ball joint shown (which are also known as frip joints) are common failures in Peugeots and Citroëns, due to water ingress into the bearing causing rusting and premature failure.

Problems may arise when replacing these ball joints. During the removal of the failed ball joint it is common for the inner race to remain attached to the wheel hub (See Figure 1&2). This then causes fitment problems when the new febi ball joint (28355 or 38490) is fitted. It is imperative to ensure that the full ball joint including the inner race is fully removed from the wheel hub.

The hub must be thoroughly cleaned before fitting the new febi ball joint ProKit which comes with a protection cap to help stop future water ingress.
