AUTOBIZ

TECH TIPS

7th Issue
April 2016

This 7th issue of Tech Tips has a roundup of all the Tech Tips that were published in Autobiz since June 2015.

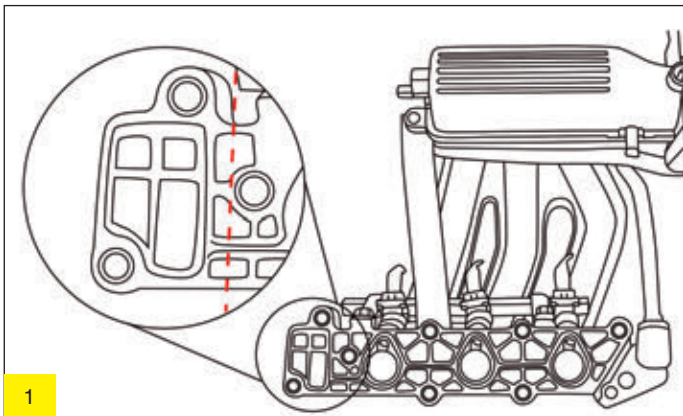
A common problem on the 800cc Daewoo/Chevrolet Matiz is corrosion to the alloy cylinder head and warping of the plastic inlet manifold, ventually resulting in a coolant leak between the two. Blue Print explains how this problem can be easily overcome to get the engine running properly again.

The plastic inlet manifold on this three cylinder engine includes a 'blanking plate' moulded to the end, which seals against a water-way on the cylinder head. Over time the plastic deteriorates, eventually resulting in a coolant leak. ADG06290 is an inlet manifold repair kit to give a long term cure to this particular problem, comprising of a high quality blanking plate and modified manifold gasket. Carrying out the modification is straightforward and is illustrated below.

Once removed from the car, hold or carefully clamp the plastic inlet manifold. Mark the coolant blanking section of the manifold that you are about to saw through, making sure that you mark a section slightly larger than the size of the new blanking plate (fig. 1). This is to ensure there is no interference between the manifold and new blanking plate when they are fitted to the engine. Check twice – cut once!

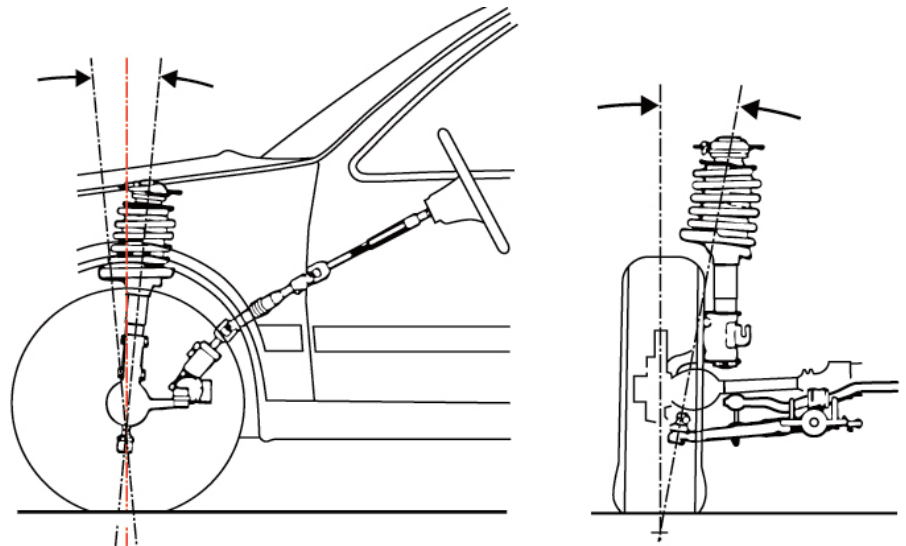
Fig 2. The effect of the strut top mounting on axle geometry

When rubber-metal parts age, the material becomes brittle and cracks are formed. Fluctuating temperatures and contamination due to oil intensify this effect. The rubber parts of the strut top mounting wear, causing loss of rebound even if the shock absorber is still intact. The consequences can be anything from steering wheel vibration and knocking noises to rolling on bends and tyre damage. Worn bearings also impair the axle geometry and the necessary front axle settings for camber, castor and steering-axis inclination (Fig. 2). Continuous steering corrections may be necessary to keep the vehicle on track when a strut top mount is worn. This is because a worn strut mounting causes friction; the steering power required may increase by up to 20%.

Strut top mountings should always be checked during an inspection, and replaced if necessary, because of the safety aspects mentioned. The strut top mountings should always be renewed in pairs, particularly when replacing the shock absorbers. As the steps required are largely the

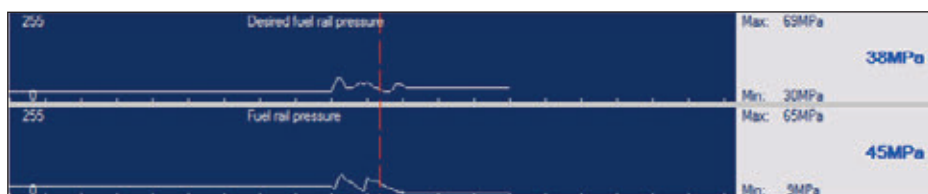
Figure 2 - The actual fuel pressure sometimes exceeded the desired fuel pressure

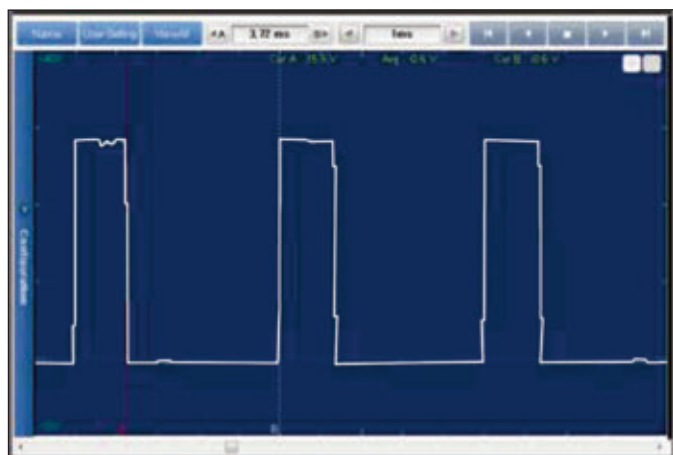
Figure 4 - The SCV duty cycle with the engine at idle

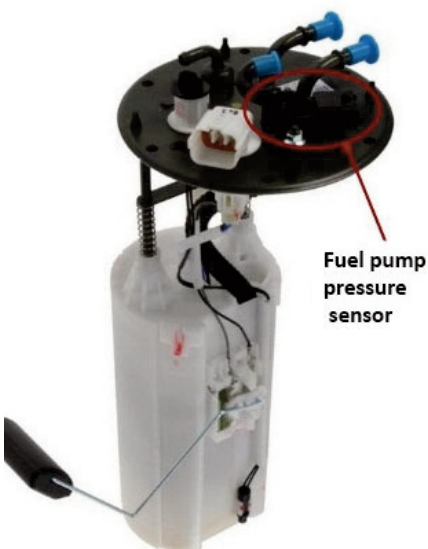
Fuel pump pressure sensor

- Check the condition of the fuel filter. In these vehicles the replacement period is 30,000 km.
- Check the pressure of the injection rail. Power, earth and signal of the injection rail pressure sensor when the engine is working properly is shown below:
 - PIN1: Ground
 - PIN2: Sensor signal (0.5 Volt on contact /

- 1.2 Volt with idling engine / 2.4 Volt with engine at 3,000 rpm)
- PIN3: 5 volt power supply.

Access the fuel gauge located under the rear seats. Check that there is no dirt or shavings inside the fuel tank. In these models, there is a problem with the paint that coats the inside of the fuel tank; its loosening causes the generation of waste, interfering with the fuel intake of the fuel pump.

Clean the inside of the fuel tank, the gauge and the incorporated filter. Replace the fuel filter and also the pressure sensor within the fuel pump itself.

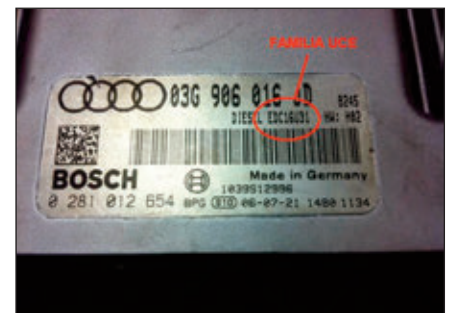
The affected engine control units are made by BOSCH and they belong to the EDC family: EDC16.U1, EDC16.U31 and EDC16.U34.

The ECU type can be read off the label

You have to reprogramme the ECU in order to restore the default settings. In this way, the vehicle will start again at the correct crankshaft revolutions specified by the manufacturer.

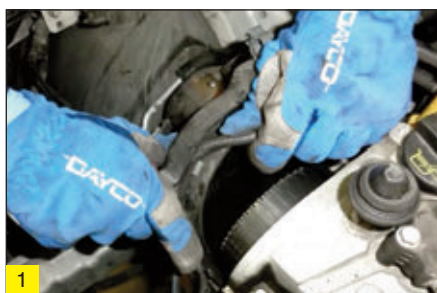
to detach the wiring connected to the upper half (figure 1) and remove both parts of the timing case.

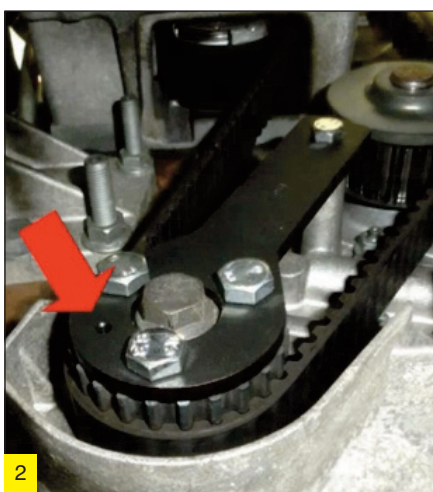
At the opposite end of the head, remove the oil vapour collection housing, followed by the vacuum pump mounting bracket and then the pump itself, to allow the installation of the camshaft timing tool (2000034400). Returning to the timing drive end, install the crankshaft timing tool (2000004500) ensuring that the pin in the pulley is located correctly (figure 2).

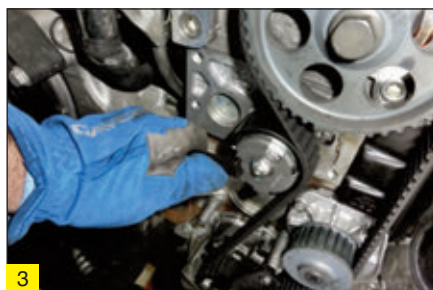
but do not remove its bolt, so the pulley can rotate on the shaft. Replace the tensioner and the belt with the new ones from the kit and using tool (1860987000), rotate the tensioner anti-clockwise to the end of its stroke (figure 3) and tighten the nut to 27Nm. Making sure the camshaft pulley doesn't move by holding it with a suitable

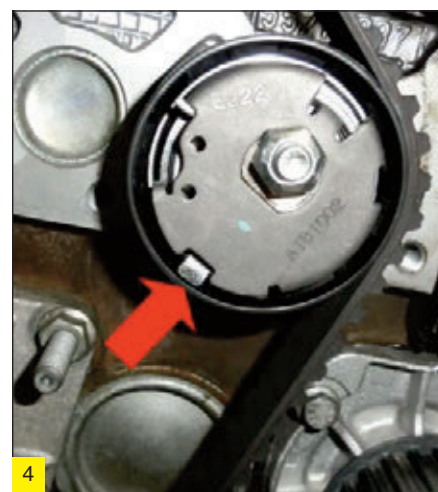
Remove the camshaft and crankshaft timing tools, and by using the crankshaft pinion, rotate the engine several times and reinstall the tools. Then, while holding the tensioner with the tool, loosen the fastener and rotate the tensioner until its index is centred in the reference window (figure 4), then retighten the fastening to 27Nm.

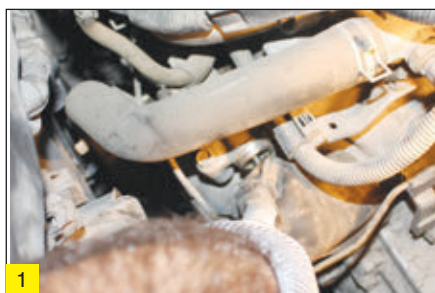
Disconnect the air sensor cable on the air filter box and remove the air filter box as a complete unit, to expose the top of the gearbox. Carefully remove the two bolts that hold the slave cylinder in place and remove the bolt that holds the hydraulic clutch line. Take care not to tear the protective push rod boot (figure 1). The slave cylinder and pipe does not

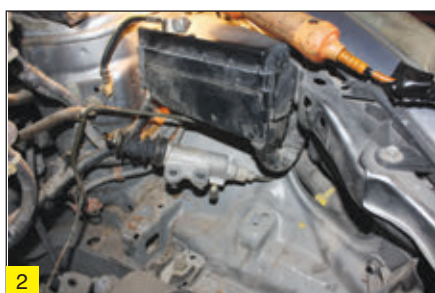
require complete removal and can be stowed carefully, making sure the pipe is not bent in anyway (figure 2).

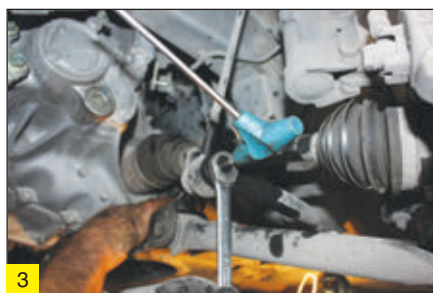
The vehicle can now be raised, and the engine under tray can be removed. Drain the transmission oil. The next stage is to remove the drive shafts, which means disconnecting the ball joints and stabilizer links on both sides. Remove the drive shaft nut, then by suitable means, push the drive shafts inside. Using a 5mm Allen key and 14mm ring spanner, release the ball joint pin (figure 3)

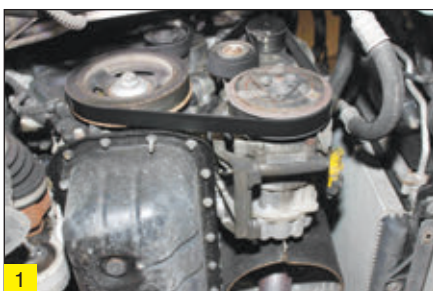
Remove the O/S/F wheel and wheel arch liner; this gives access to a plastic shield which can then be removed. The auxiliary drive belt is now fully visible and accessible (fig 1), make a

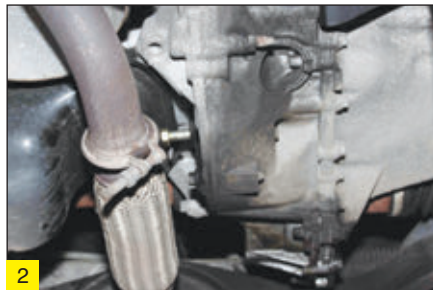
Raise the vehicle, insert the crank locking pin from the back of the engine through and into the back of the flywheel (this is a locking device not a timing location), located in a central position (fig 2). Undo the centre bolt on the crankshaft pulley and remove pulley and locking pin, remove the crankshaft position sensor and shield. Undo the five lower

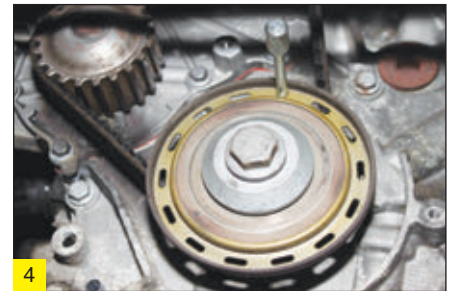
timing belt cover bolts and remove the cover. Refit crankshaft pulley bolt and rotate engine until crank, cam and fuel pump locations align. Lock crank, cam and fuel pump with pins (figs 3 and 4), slacken the tensioner and remove, and then remove the timing belt.

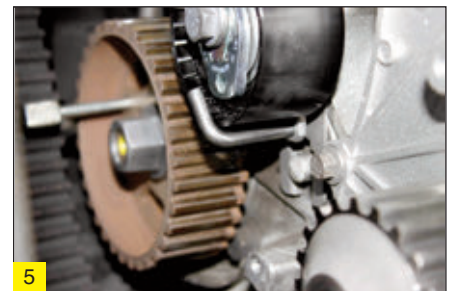
Carry out a thorough inspection of the timing belt area including pulleys and water pump. Replace the timing belt tensioner, making sure it is located correctly (fig 5), idler and fixings supplied. Replace the tensioner
