AUTOBIZ
TECH TIPS

7th Issue
April 2016

TECH TIPS

This 7th issue of Tech Tips has a roundup of all the Tech Tips that were published in Autobiz since June 2015.

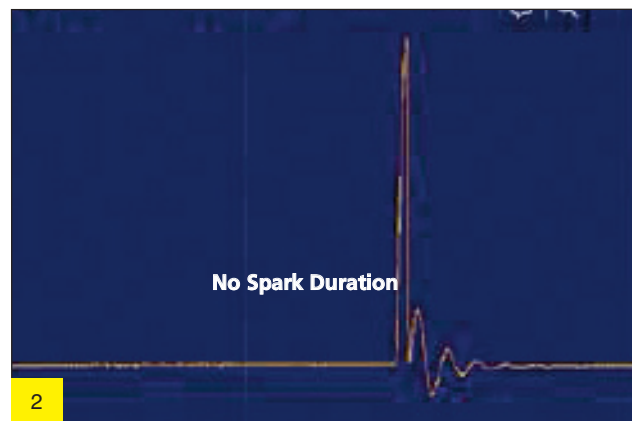
was an issue with No. 4 cylinder (Figure 2). All the ignition energy was being used for the initial jump

There wasn't any spark duration in cylinder number 4

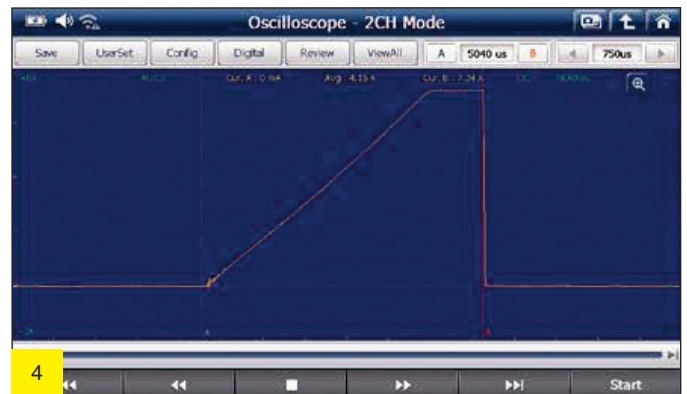
The coil for cylinders 2 and 3 charged up quickly to a maximum current of 7.24 amps

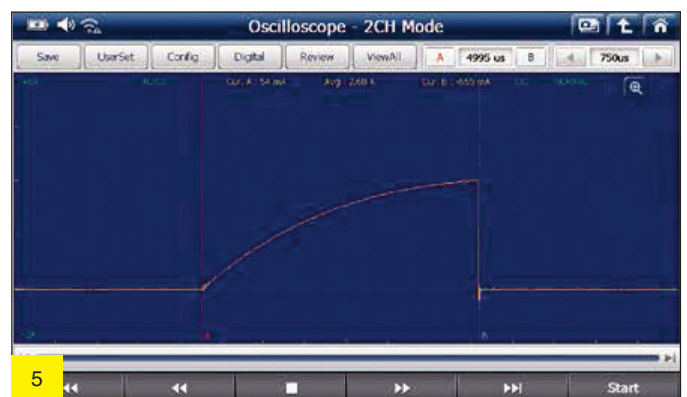
On measuring the suspected faulty coil for cylinders 1 & 4, the dwell time was the same, but the coil was slower to charge and it only had a peak of 4 amps. With this information I concluded that the misfire was due to a high resistance in the integrated driver end stage. With this affecting the primary circuit, it will then affect the secondary ignition voltage. Quoting ohms law, if you have a high resistance, less current will

The coil for cylinders 1 and 4 charged up slowly, and only reached a maximum current or 4 amps

I replaced the coils on the bracket (which come as a pair), carefully removing the old plug leads. The No.3 plug lead was seized in the coil due to corrosion. This did not show up in any of my electrical tests, which meant it had a good contact and any resistance was not affecting the secondary ignition on that cylinder. However, it meant I had to replace the plug leads as well.

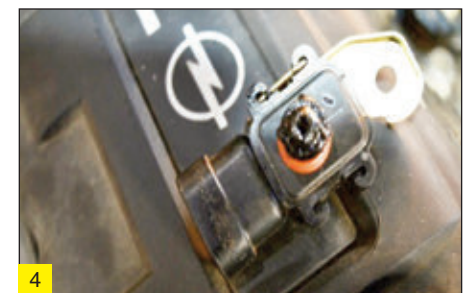
Because the turbo was developing much higher boost than shown on the diagnostic tool, and therefore the ECU, the next step was to remove and examine the turbo boost pressure sensor. The problem became instantly obvious on inspection (fig 4). The turbo boost pressure sensor was badly blocked with carbon, as was the intake manifold. On cleaning the manifold and replacing the boost pressure sensor, full power was restored to the car.

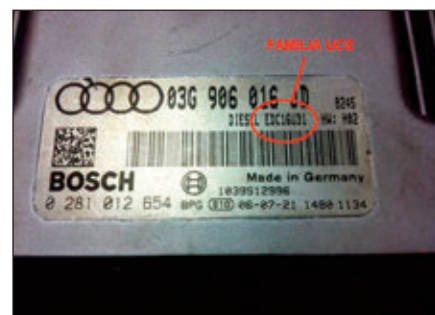
The ECU type can be read off the label

You have to reprogramme the ECU in order to restore the default settings. In this way, the vehicle will start again at the correct crankshaft revolutions specified by the manufacturer.

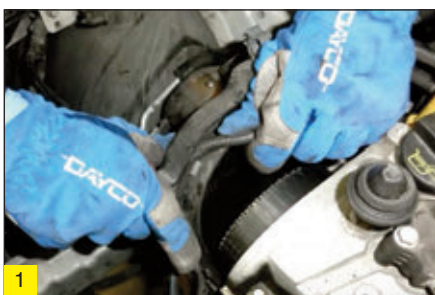
to detach the wiring connected to the upper half (figure 1) and remove both parts of the timing case.

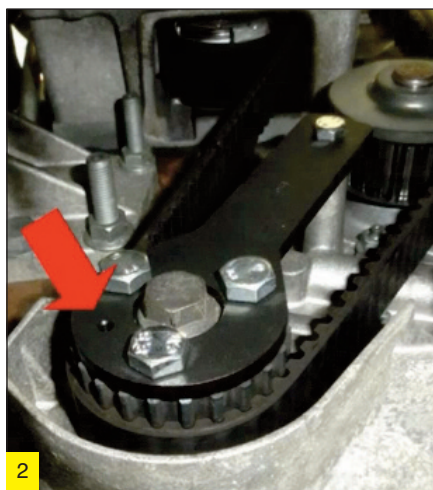
At the opposite end of the head, remove the oil vapour collection housing, followed by the vacuum pump mounting bracket and then the pump itself, to allow the installation of the camshaft timing tool (2000034400). Returning to the timing drive end, install the crankshaft timing tool (2000004500) ensuring that the pin in the pulley is located correctly (figure 2).

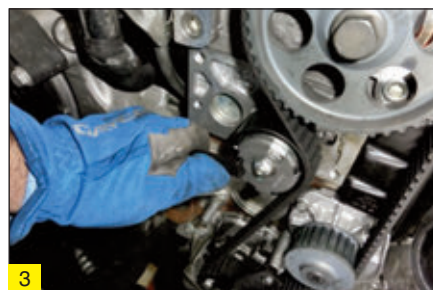
but do not remove its bolt, so the pulley can rotate on the shaft. Replace the tensioner and the belt with the new ones from the kit and using tool (1860987000), rotate the tensioner anti-clockwise to the end of its stroke (figure 3) and tighten the nut to 27Nm. Making sure the camshaft pulley doesn't move by holding it with a suitable

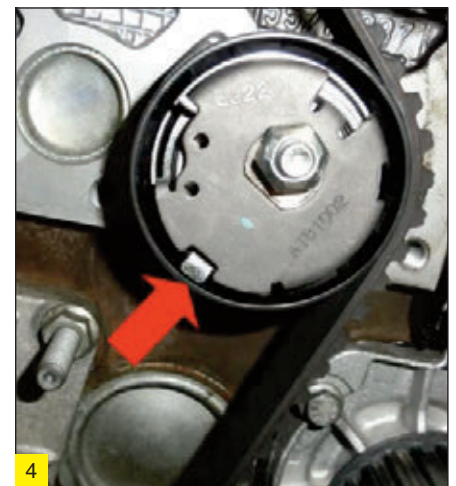
Remove the camshaft and crankshaft timing tools, and by using the crankshaft pinion, rotate the engine several times and reinstall the tools. Then, while holding the tensioner with the tool, loosen the fastener and rotate the tensioner until its index is centred in the reference window (figure 4), then retighten the fastening to 27Nm.

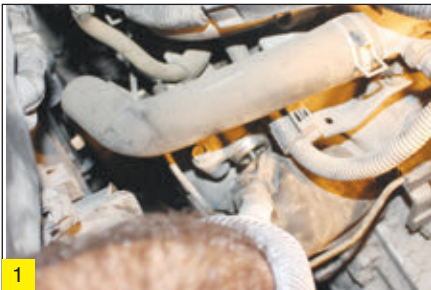
Disconnect the air sensor cable on the air filter box and remove the air filter box as a complete unit, to expose the top of the gearbox. Carefully remove the two bolts that hold the slave cylinder in place and remove the bolt that holds the hydraulic clutch line. Take care not to tear the protective push rod boot (figure 1). The slave cylinder and pipe does not

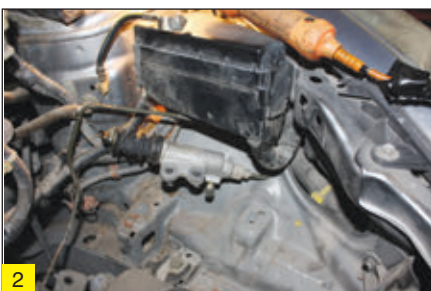
require complete removal and can be stowed carefully, making sure the pipe is not bent in anyway (figure 2).

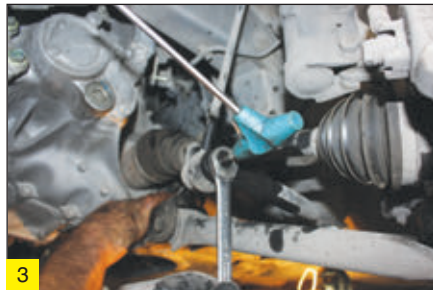
The vehicle can now be raised, and the engine under tray can be removed. Drain the transmission oil. The next stage is to remove the drive shafts, which means disconnecting the ball joints and stabilizer links on both sides. Remove the drive shaft nut, then by suitable means, push the drive shafts inside. Using a 5mm Allen key and 14mm ring spanner, release the ball joint pin (figure 3)

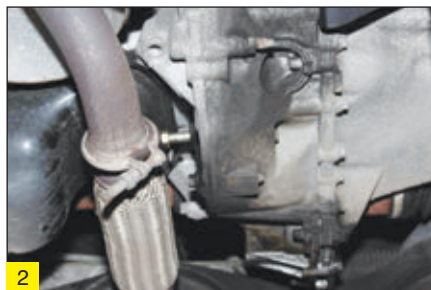
Raise the vehicle, insert the crank locking pin from the back of the engine through and into the back of the flywheel (this is a locking device not a timing location), located in a central position (fig 2). Undo the centre bolt on the crankshaft pulley and remove pulley and locking pin, remove the crankshaft position sensor and shield. Undo the five lower

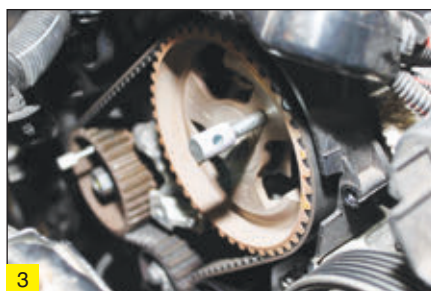
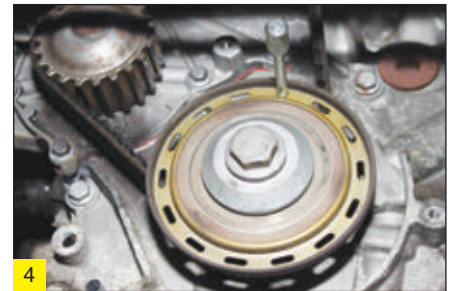
timing belt cover bolts and remove the cover. Refit crankshaft pulley bolt and rotate engine until crank, cam and fuel pump locations align. Lock crank, cam and fuel pump with pins (figs 3 and 4), slacken the tensioner and remove, and then remove the timing belt.

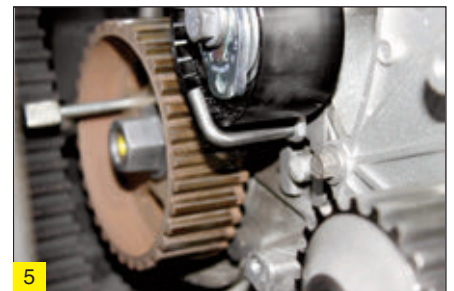
Carry out a thorough inspection of the timing belt area including pulleys and water pump. Replace the timing belt tensioner, making sure it is located correctly (fig 5), idler and fixings supplied. Replace the tensioner
