AUTOBIZ

*TECH TIPS*

2nd Issue  
Dec 2011

## Welcome to the second edition of the Autobiz Tech Tips Supplement

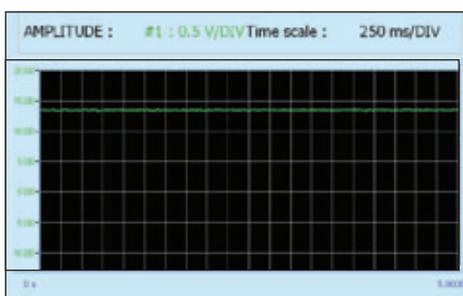
When the ignition is switched on or the engine is running, battery voltage should be present on the supply line to the sensor. This may be measured using a DC voltmeter, or an oscilloscope as shown in Figure 1.

Figure 1: Oscilloscope trace of the supply voltage to the wheel speed sensor

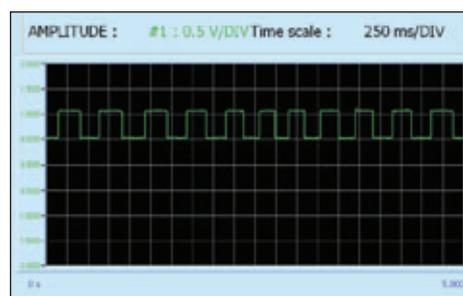
Figure 2 shows the signal produced when the road wheel is rotated slowly at constant speed.

Figure 2: Oscilloscope trace of the signal voltage of the wheel speed sensor as the wheel rotates at constant speed

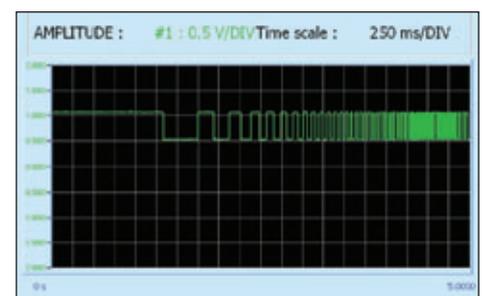
Figure 3 illustrates how the signal varies as the road wheel is accelerated from stand still. The 50% duty cycle remains, the amplitude is constant but the frequency of the waveform increases which is directly proportional to the wheel speed.

Figure 3: Oscilloscope trace of the signal voltage of the wheel speed sensor as the wheel accelerates from a stop position

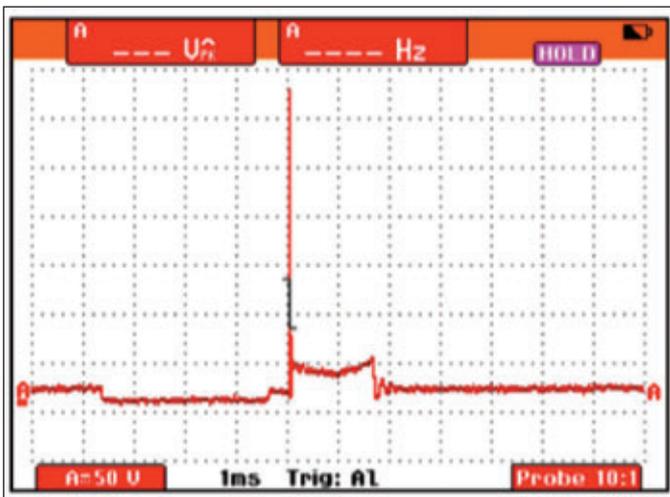
As you can see in figure 1, there was a textbook primary wave pattern on two of the coils. Just prior to the firing line you can see the current limiting hump, indicating that the coil had become fully charged, and that the engine ECM had in fact stopped charging this particular coil.

Two of the coils in the Mercedes were perfect, as can be seen in this textbook coil primary trace.

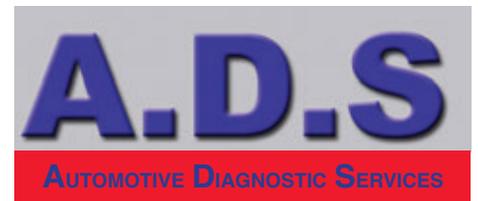
Picture 1 shows the signal of the ABS wheel sensor at 30 kph, and all appears to be normal. The 'peak to peak' value of this alternating current is approximately 3 volts. Typical for this signal is an offset. The signal is not alternating around 0 volts, but at about 0.8 volts. An offset voltage is used so that the Electronic Control Module (ECM) can better recognize a short-circuit fault in the sensor wiring. The offset can be measured with a multimeter when the wheel is not rotating. At higher speeds, the problem became very apparent, as shown in picture 2.

Figure 1: The ABS wheel sensor signal at 30 Kph looked to be perfectly normal

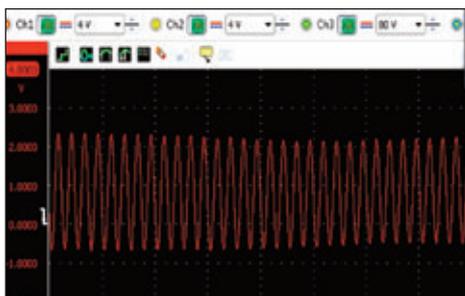
The ATS 5004D oscilloscope showed more information about the wheel speed sensor signal than could be seen with a multimeter. The irregularities in the sensor signal as shown by the scope were very apparent. The irregularities were rhythmic, not random, leaving only a mechanical fault as the problem. The damaged wheel speed disk was replaced and the ABS system was returned to a fully functional state. Without an oscilloscope, the cause of the fault would have been much harder to determine.

Figure 2: The sensor signal at higher speeds showed an obvious fault, at arrows
