# LuK Clutch Academy

## Opel Meriva 1.4P

REXPERT Alistair Mason replaces the clutch on an Opel Meriva after the customer reported that the clutch was 'slipping'. Like other Opels, components are bolted to the subframe, which has to be lowered, so these helpful tips from LuK should help speed the job along.

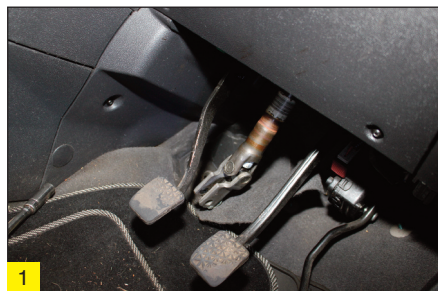
**D**isconnect the steering column universal joint (Fig 1) from the steering rack, so it can be lowered with the subframe, and cable-tie the radiator to the bonnet locking platform bracket, as it's normally supported by the soon-to-be-lowered subframe.

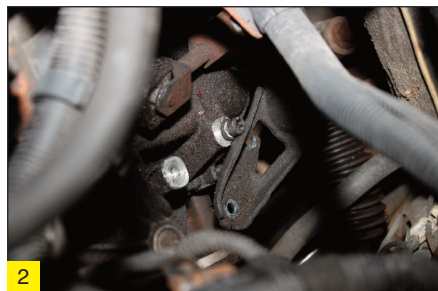
Unbolt the gear linkage from the top of the gearbox (Fig 2), and remove the pin from the gear linkage pin.

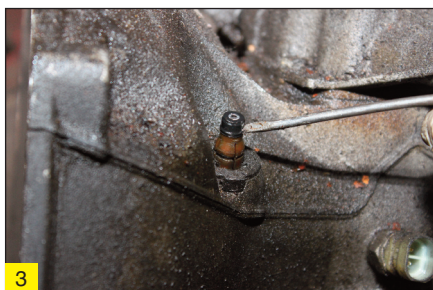
Disconnect the concentric slave cylinder (CSC) pipe and follow instructions in the new CSC box i.e. locate and discard the sealing cap (Fig 3), then, if possible, blank the hose. Support the engine and remove the rear tie bar bracket bolts (Fig 4) and disconnect the oxygen sensor multiplug.

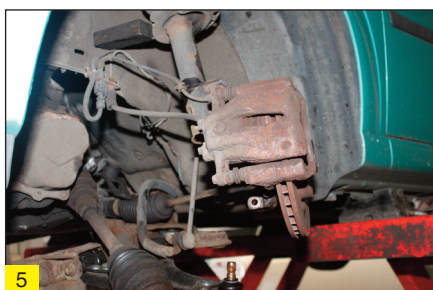
Unscrew the two bolts securing the front engine tie rod bracket and allow it to hang. Support the subframe on a transmission jack, and undo three of the four subframe bolts, leaving the front RH bolt loose but engaged. Separate the LH lower ball joint and lower the subframe supported on the jack. Secure the LH MacPherson strut away from the body with a wooden block (Fig 5) and

remove the LH driveshaft.
