## **febi 32783, 37680**

Various Peugeot, Citroën and DS models

## Rear Brake Disc with wheel bearing

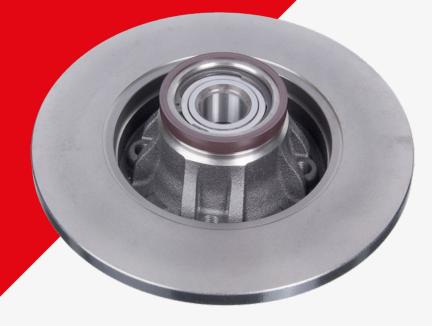
Fig. 1 Damaged reluctor due to contact with the sensor

With the old brake disc removed from the vehicle, the wheel speed sensor should be inspected for excess corrosion surrounding the mounting area. It is important to note that any excess metal corrosion can alter the position of the sensor – affecting its functionality. This can lead to direct contact with the reluctor, causing damage to the new brake disc assembly (Fig.1). Subsequently, an increased air gap between the sensor and the reluctor can also occur, resulting in an antilock brake system fault - logged as a sensor implausibility signal fault code in the brake control unit.

Therefore, during the installation of a new brake disc it should be identified if the speed sensor is in contact with the multipole reluctor, or if the air gap is not correctly aligned. If discovered to be incorrect, the brake disc and speed sensor should be removed. The sensor seating location should be cleaned of corrosion and - if damaged - the sensor refitted or replaced. With the new brake disc re-installed, and the sensor correctly aligned, a clear 1-2mm air gap between the reluctor and the sensor will be visible (Fig. 2).
