Overcoming component issues

A technician rang the Autobiz Technical Helpline about a 2017 Opel Vivaro. The Vivaro was reporting an AdBlue mileage countdown, and the initial scan of the vehicle reported code P2033. This code often refers to any issue that would affect the efficiency of the Selective Catalytic Reduction (SCR) system.

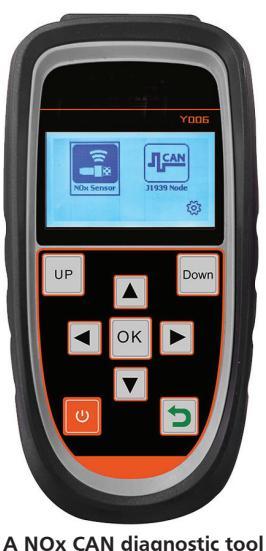
A NOx CAN diagnostic too can directly read the data from a NOx sensor serially on the live data, with the engine at operating temperature on fast idle. NOx is measured in parts per million (PPM).

With only one sensor fitted on this vehicle, mounted behind the SCR catalyst, we expected to see around 35-40 PPM, if the system is operating correctly. The single NOx sensor was displaying 65,535 PPM, a default value for a nonoperational sensor.

In this instance, the scan tool showed that the replacement NOx sensor was not sending any signal, so another replacement sensor, from an OE supplier, was fitted. After a final reset and road test, the live stream data from the NOx sensor was a healthy 32 PPM. The mileage counter for the AdBlue system was reset, and the repair was now complete.
