How important is a correct tensioner installation January 2015

The VW Golf range (1997-2006) features a variety of engines with different drive system layouts, but one of the most intriguing is associated with 1.4L 16V engines. Some of these twin cam engines feature two separate drive belts in two different sizes. One main camshaft belt provides the timing. A smaller cam belt drives the second cam.

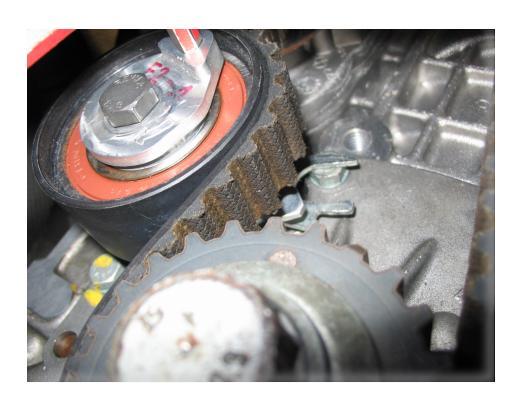
In a recent case, an inspection showed no obvious problem with the main drive. The smaller secondary belt had failed. Careful examination showed that the belt had been significantly reduced in width.

It had been 'worn away' on the edge closest to the engine block, with the result that the narrower belt had been unable to sustain the load. The belt had snapped, allowing the piston to valve contact and as a result, the engine was destroyed. Debris from the smaller belt had found its way onto the rest of the drive system.

The likely cause of reduced width to a belt is regular contact with the engine block. This would be clear from a scoured or polished surface on either the drive system cover or the engine block. In this case, no such evidence was found. However, there was such on the back plate on the automatic tensioner, which would not normally be within the operating plane of the belt.

Reduction in width had been caused by contact with the belt tensioner, rather than the engine block. Failure was a symptom of a very different problem.

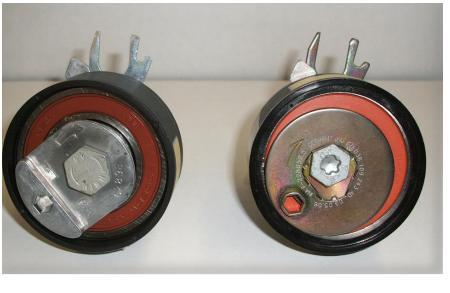
Automatic tensioner

With the automatic tensioner in the correct position, contact with the small secondary belt is impossible.

However, it is possible to install this automatic tensioner upside down and in such circumstances, contact with the belt is inevitable. The evidence supported the view that this automatic tensioner had been fitted incorrectly.

- Small drive belt made contact with the back plate of the tensioner
- The edge of the belt was pared away
- Stress increased until the belt snapped
- Piston to valve contact
- Destruction of the engine

Regardless of the number of times the procedure may have been carried out on a particular model, installing a tensioner upside down is a basic error that any installer can make.

For those drives where installation of the belt drive may be more complex, Gates belt kits include all the information necessary to install belts and tensioners correctly.
