# **Technical Information**

## Checking the lateral runout of the wheel hub

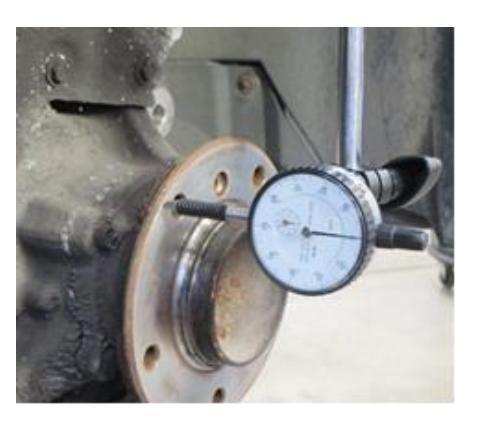
- 1. Fasten the dial gage with holder to the suspension strut
- 2. Align the dial gage at the outer edge of the wheel hub
- 3. Turn the wheel hub slowly and at a constant speed in the direction of travel
- 4. Read off the measured values

Measured over several wheel revolutions, deviations should not exceed 0.03 mm. If the deviations are greater, the hub should be replaced.

- This test should be carried out before mounting the new brake discs
- Unevenness on the contact face of the wheel hub can lead to warping of the brake disc and therefore axial runout.
- Any hub runout present will cause twice the disc runout at the outer edge of the brake disc
