## Timing belt clinic Malcolm Short, Schaeffler Peugeot 206 1.4 HDi 8HX/8HZ

Timing belt replacement is due every 140-160,000 miles, or 10 years whatever comes first, depending on date of manufacture, but always check the manufactures recommendations. INA takes a closer look at this popular model.

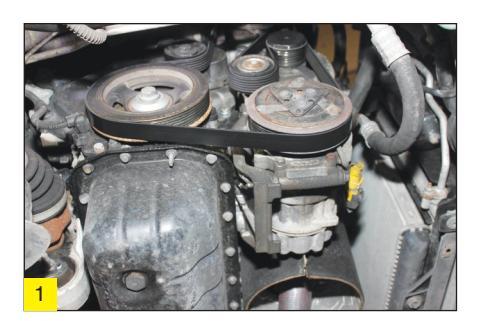
Remove the O/S/F wheel and wheel arch liner; this gives access to a plastic shield which can then be removed. The auxiliary drive belt is now fully visible and accessible (fig 1), make a

note of routing if required, rotate the auxiliary belt tensioner clockwise to the released position, lock with a pin, remove the auxiliary belt and check for wear and deterioration. Replacement is advised during timing belt replacement.

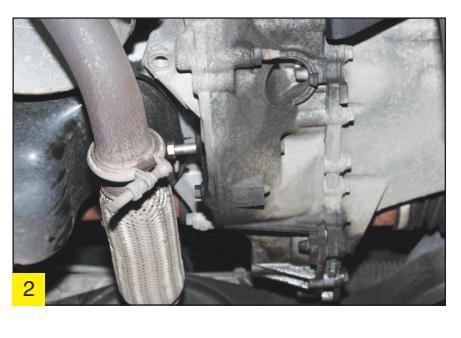
Raise the vehicle, insert the crank locking pin from the back of the engine through and into the back of the flywheel (this is a locking device not a timing location), located in a central position (fig 2). Undo the centre bolt on the crankshaft pulley and remove pulley and locking pin, remove the crankshaft position sensor and shield. Undo the five lower

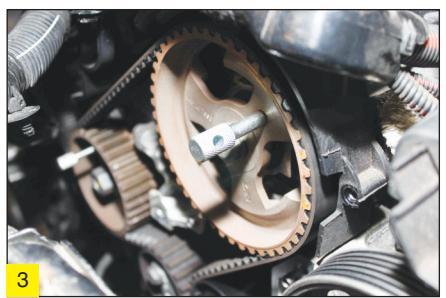
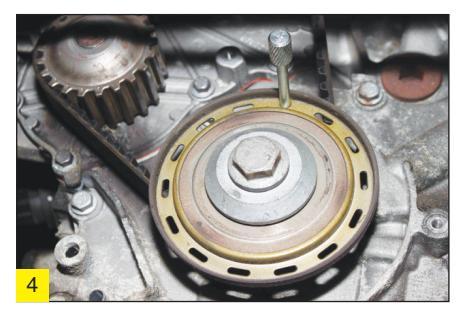
timing belt cover bolts and remove the cover. Refit crankshaft pulley bolt and rotate engine until crank, cam and fuel pump locations align. Lock crank, cam and fuel pump with pins (figs 3 and 4), slacken the tensioner and remove, and then remove the timing belt.

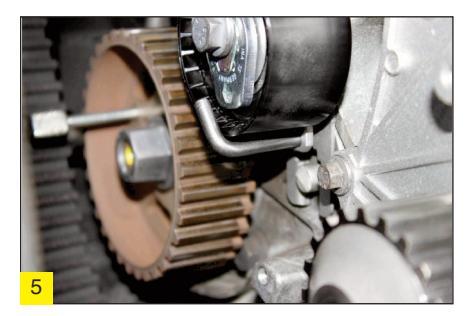
Carry out a thorough inspection of the timing belt area including pulleys and water pump. Replace the timing belt tensioner, making sure it is located correctly (fig 5), idler and fixings supplied. Replace the tensioner

bolt, the idler and stud. Fit the new timing belt in the following order, crankshaft, idler, camshaft, water pump, fuel pump and then the tensioner. Tension the belt by aligning the marks on the tensioner and torque bolt. As per instructions, rotate the engine ten revolutions and recheck timing and tension, (when we carried this out the fuel pump locking pin did not line up, after two more rotations it all aligned and locked with the pins).
