LuK Clutch Academy Iveco Daily pull type

REPXPERT Alistair Mason is replacing the clutch in a 2014 Iveco Daily 35C17 that has covered 56,000 miles and had been recovered with no drive. The scheduled time for the repair is 4.20 hours and with no specialist equipment required, this makes a great repair for any independent workshop.

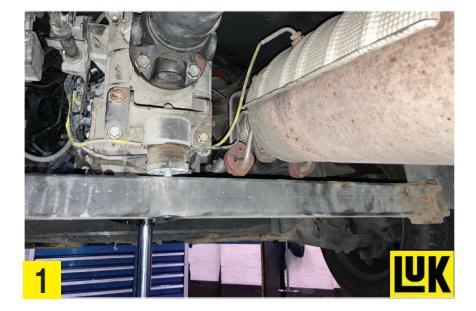
With the vehicle safely positioned on the lift, open the bonnet, disconnect the battery earth lead and stow it safely. This is the only part of the repair that is carried out at ground level. Raise the lift to gain access to the underside, support the gearbox with a transmission jack and then remove the gearbox crossmember, by detaching the gearbox mounting nut and crossmember to chassis bolts (Fig 1). With the

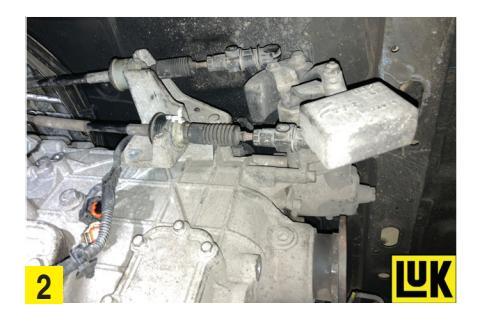
This step gives good access to the electrical multiplugs on the side of the gearbox, so disconnect them, unbolt the bracket and stow away from the gearbox. The gear cables can now be removed (Fig 2) by levering the cable off the ball joints and then easing the outer cables out of their retaining brackets.

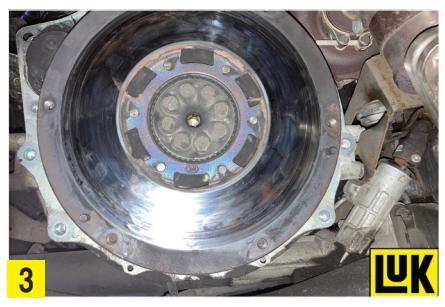
In this example, the clutch fault then became evident as, due to 'slipping' and overheating, the clutch lining had become detached from the clutch plate and broken up, which had also caused the dual mass flywheel (DMF) to be exposed to excess heat. This was evident by the blue colour on its surface, affecting the internal springs and grease (Fig 3), (Note – it is good practice to clear and vacuum up the broken clutch lining). At this point the customer was contacted and authorisation to also replace the DMF was given.

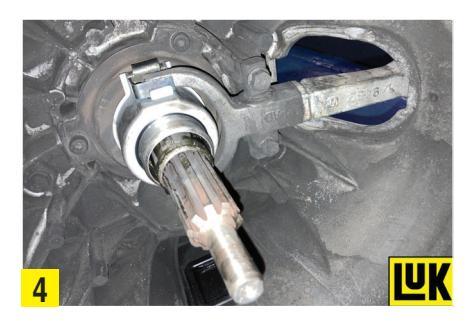
Remove the clutch plate and any excess grease, apply a light smear of high melting point grease to the pivot points of the release arm/release bearing, fit the new release bearing, engaging it into the release arm as

it passes up the guide tube and, when in position, ensure the release arm operates correctly and freely (Fig 4).

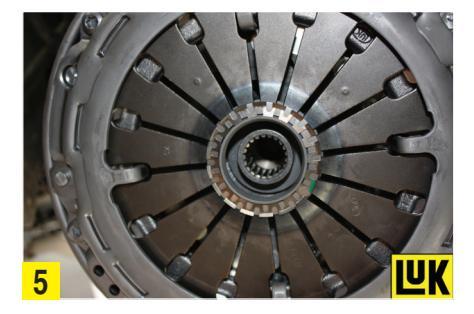
Replace the DMF and torque the bolts to the manufacturer's specification, then clean the DMF clutch face and new clutch pressure plate face using some brake and clutch dust cleaner. Using a clutch alignment tool, mount the new clutch plate onto the flywheel with 'gearbox side' facing away from the engine, locate the clutch cover onto the flywheel

dowels, insert the six clutch bolts, tighten them in an even and sequential process and finally, torque to the manufacturer's specification (Fig 5).

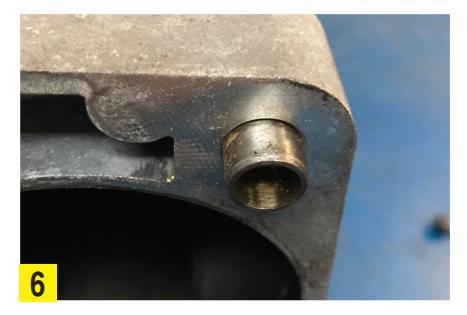
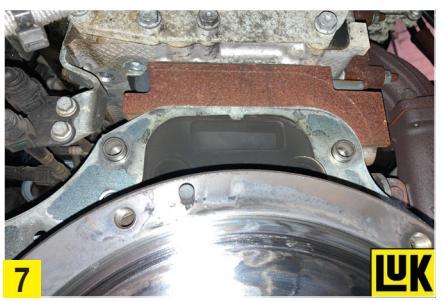
A crucial part of this repair is the alignment between the engine and gearbox, so that the release bearing locks into the clutch cover on installation. To ensure this alignment is correct, it is critical that the engine to gearbox alignment dowels are installed (Fig 6 & 7). So, prior to fitting the gearbox, ensure all the alignment dowels are inserted correctly.
