LuK Clutch Academy Academy Academy Audi A6 2.0TDi

The Audi A6, launched in 1994, is still a popular executive vehicle on the road today. The technical team at LuK take a closer look at the Audi A6 2.0TDi saloon for a clutch and flywheel replacement, and offer a few handy hints that should prove useful to any workshop looking to undertake the repair.

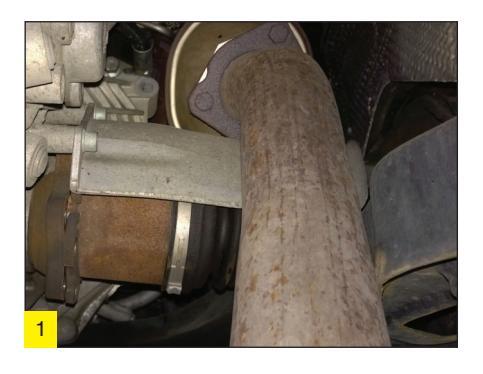
Remove both of the drive shafts from the transmission side, and stow the shafts out of the way using a couple of bungee ties. The offside drive shaft also has a heat shield that should be removed (fig 1). At this stage, it is possible to loosen the bottom four bell housing bolts, keeping in mind one of them is a nut and bolt arrangement.

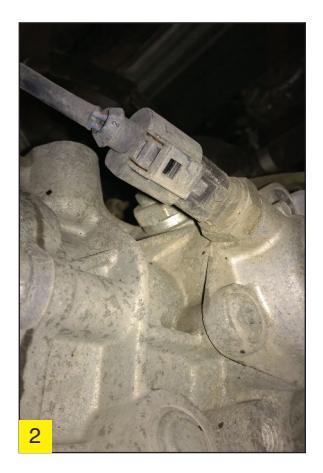
Disconnect the reverse light connecter (fig 2) and remove the gear link stabiliser bolt (fig 3. Remove the upper gear link stabiliser bolt, which is a captive bolt and washer from the top of the gearbox. Remove the bolt that holds the pushrod in place, and remove the pushrod. Remove the selector shaft nut and disconnect the lever from the selector shaft (fig 4).

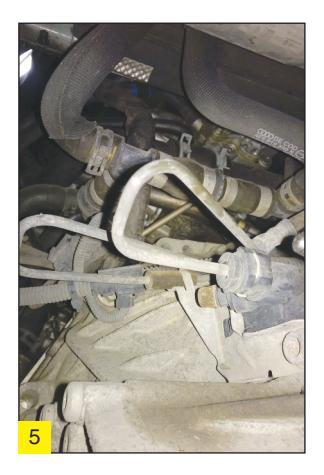
Clamp the hydraulic line at the rubber pipe section and disconnect the external slave cylinder (fig 5), keeping the line connected, and stow safely. The remaining bell housing bolts can now be loosened, and all of them can be removed. Keep in mind that the bell
