## (i) Tech Tips

## The key to success is **knowledge**

Steve Carter, eXponentia

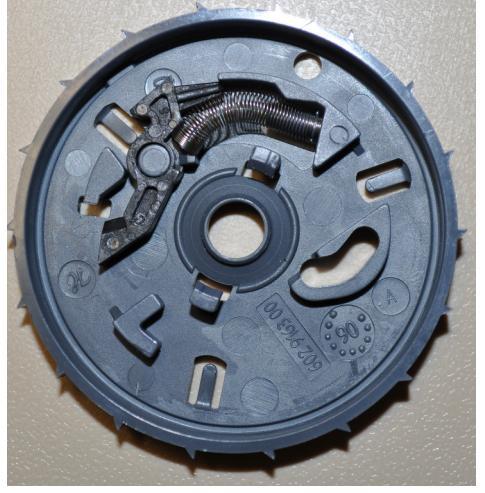
Now I love a good puzzle, but all puzzles require an answer. By removing each separate part of the take-up reel, the fault was narrowed down to the inertial latch mechanism. This is the part that latches the reel into position under heavy braking, or on some models when you pull the belt out rapidly. The latch that extends out to engage teeth to lock the reel in position would not retract, permanently locking the reel. After removing the cover on this part, the fault was easy to see, but difficult to believe. The spring that kept the latch free from the teeth had popped off the latch, allowing gravity to drop the latch onto the teeth. Just how the spring could have become unseated is not clear, but it was a clear understanding of how the seat belt worked

A spring, at top, was unseated, preventing the seat belt reel from releasing the belt

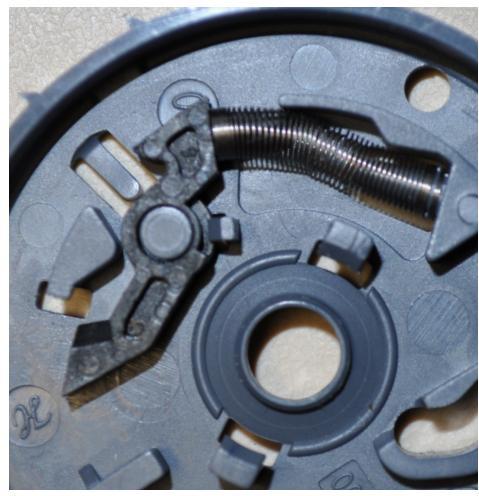
The spring in its proper position
