Audi Q5 multiple unrelated faults

In a recent case that came to the Autobiz Technical Helpline, a garage was having problems with a 2012 Audi Q5 2.0 Tdi CGLB with multiple unrelated fault codes. It did not drive well, it was continually stalling, and multiple errors were recorded in the engine ECM.

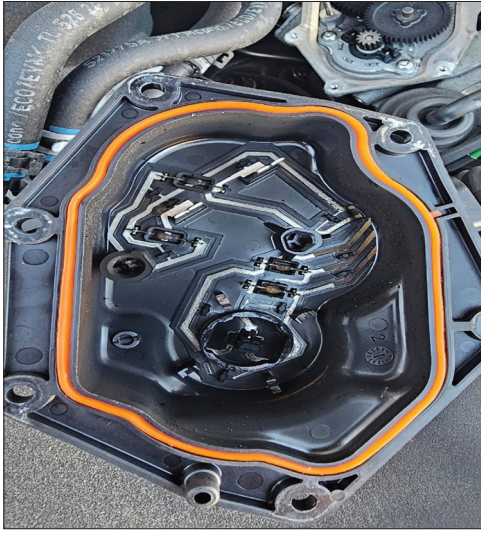
This Audi Q5 has a well known corrosion fault, when moisture enters the electronics of the EGR Valve

This Audi Q5 has a well known EGR fault. When moisture enters the electronics of the EGR Valve, corrosion occurs. Then the corrosion causes

electrical faults and starts triggering codes and running problems.

We removed the EGR valve top cover to investigate, and found corrosion. We cleaned off the corrosion to retest, but the obvious damage to the internal spring warranted a new valve to be fitted.

After disconnecting the EGR, most codes cleared successfully. After cleaning the corrosion from the electronics and reconnecting the EGR, most of the codes cleared successfully. Only the EGR disconnected codes returned, and the idle settled down after closing the EGR valve manually.
