Various BMW & VAG Group Vehicles

CLTB 0020

Ball Race Release Bearings Which Appear To Have A Plastic Contact Face

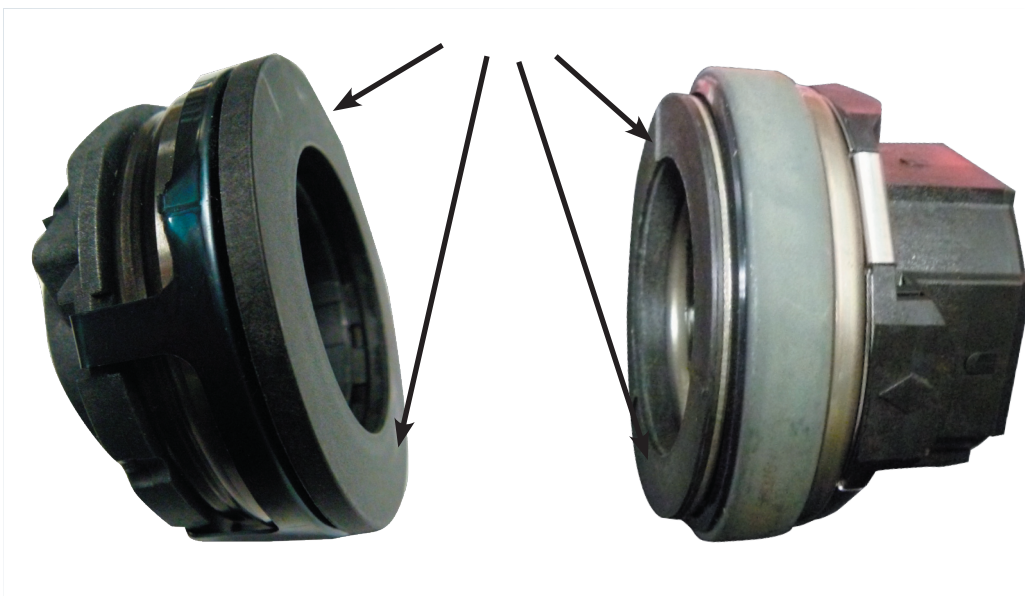
Concerns; We have had several instances now of garages quering if the plastic face is just for protection and should it be removed proir to fitting

WARNING

DO NOT REMOVE THIS PLASTIC INTERFACE

Method; Under no circumstances should this special plastic interface be removed, as it is a specific design feature of the clutch kit it is with.
