BMW 218 - Parking brake switch failing

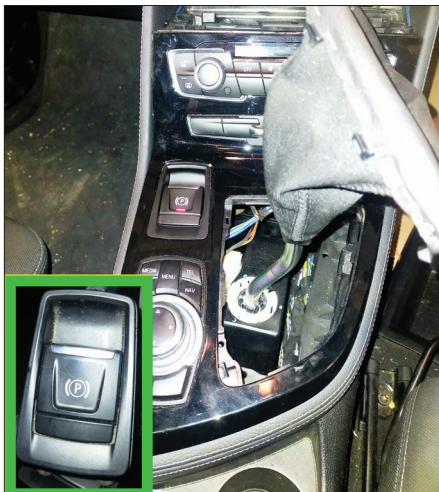
The brake switch had just enough wiggle to prevent it from releasing the EPB

The parking brakes on these BMWs are known to have software problems. In this case, the fault was associated with the parking brake switch. The switch could be felt to have a little wobble from side to side, when operated. This was allowing enough wiggle room to prevent the switch from releasing the brake on it's own.

Removing the centre console to access and replace the switch was quite straightforward, but it is always a concern levering up interior trim panels. This one went well, and a new switch was soon in place and working well.
