# BMW 5 SERIES - Fallen Mirror

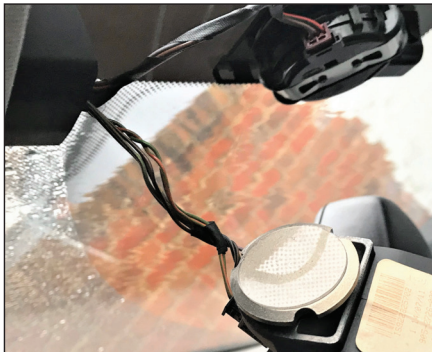
When I looked at it a year ago, I realised

**It was lucky that when the mirror fell from position it didn't damage the loom**

that the metal fixing plate had become detached from the glass, and informed him that the best option was to get the plate bonded back in place by a windscreen replacement company. They normally have the proper resin needed and this will be far more effective than anything I could do.

This time when he popped into my garage, he asked where the nearest screen fitters were and so I pointed him in the right direction.
