BMW 5 Series - Illumination problem

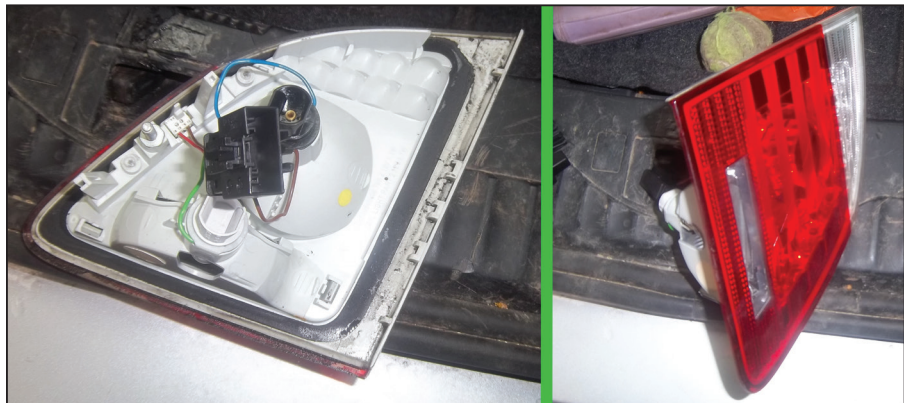
The rear lamp was not the source of the trouble, it had a faulty feed

The owner of this 2007 BMW 520D estate, had already had a look at the problem of the rear lamp, which was failing to illuminate and was concerned that the complete rear lamp needed replacing. The light was not operating and as the unit had integral LED lamps, this meant that the whole thing would have needed to be replaced.

A quick test with a volt meter was all that was needed to confirm that the problem wasn't the lamp, but the feed to the lamp. Tracing the wiring back, the problem turned out to be a failure in the short wiring loom between the rear hatch and the body.

The loom between the hatch and the body on the BMW is not only well hidden but difficult to get to, but this normally ensures that problems like this don't occur that often.
