BMW 5 Series - Past its time tyre

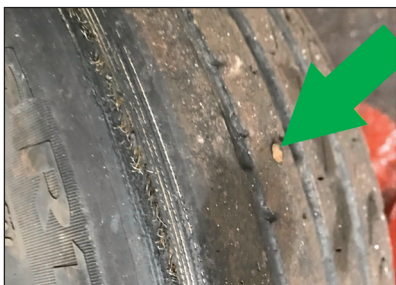
Evidence of wear was easily spotted and a nail that had been taking a free ride was also seen in the old tyre

He had felt a slight shimmy on the steering and this he had thought needed attending to, so I got to see the car for the first time since its last service nearly a year ago. A quick glance at the front tyres gave me an idea of what the steering problem was going to be.

Wear on the edge of the tyres was a good indication that the tracking was out, I also found a puncture in one of the tyres and in his usual manner, the owner asked me to fit a new set of four. He has always run the motor with Pirelli tyres and a new set of 235/45 R17 Y were fitted after having checked and corrected the tracking problem.
