# BMW X1 - Snapped and failed coil spring

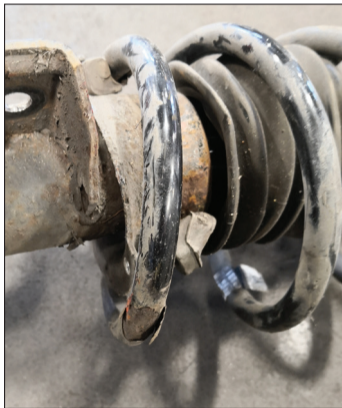
The X1 is one of the many vehicles which have a coil spring where the last coil, which sits on the strut, is smaller than

**When the smaller lower coil spring fails the suspension can drop leaving the vehicle immobile**

the circumference of the main body of the spring. This means that if the spring breaks at the end coil (and they do) the rest of the spring will go flying past the contact point.

This one went in quickly, in a downward direction and thankfully didn't take the brake hose or the ABS wire with it.

Replacement meant removal of the complete strut and disconnecting the driveshaft, but the job did go smoothly and the X1 was soon sitting on an even keel again and ready for the urban jungle.
